**SITE INVESTIGATION REPORT  
FOR MULTIPLE BUILDINGS  
SOUTHWEST REGION  
PINE BLUFF ARSENAL  
PINE BLUFF, ARKANSAS**

CONTRACT NO. W912DY-05-D-0010  
DELIVERY ORDER NO. 05  
BHATE PROJECT NO. 9060216

February 2007

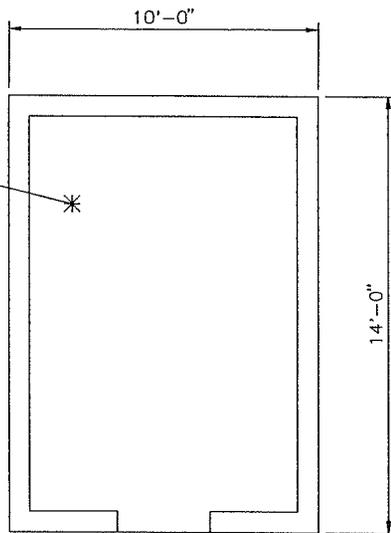
BUILDING # 15-103

15-103-1,2  
3 TAR PAPER  
RS  
NEGATIVE

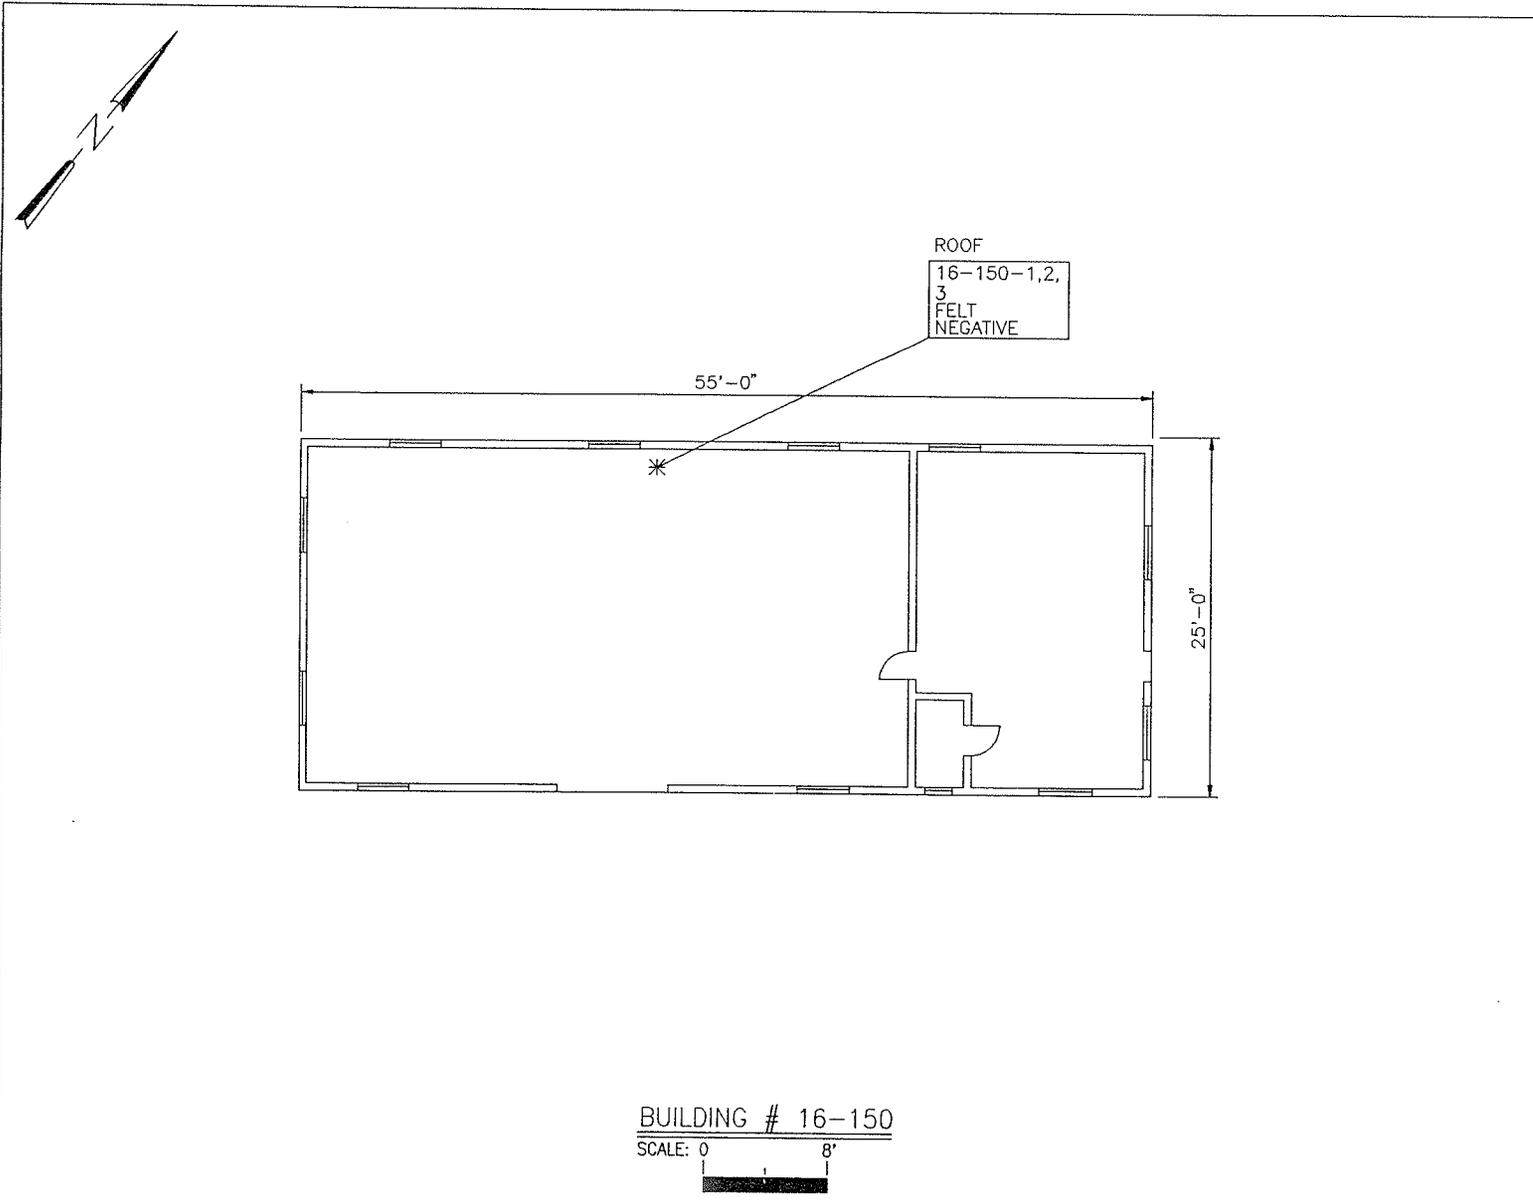
BUILDING # 16-150  
 SCALE: 0 8"

SIDING, WALL PANELS, AND CEILING ARE TRANSITE.

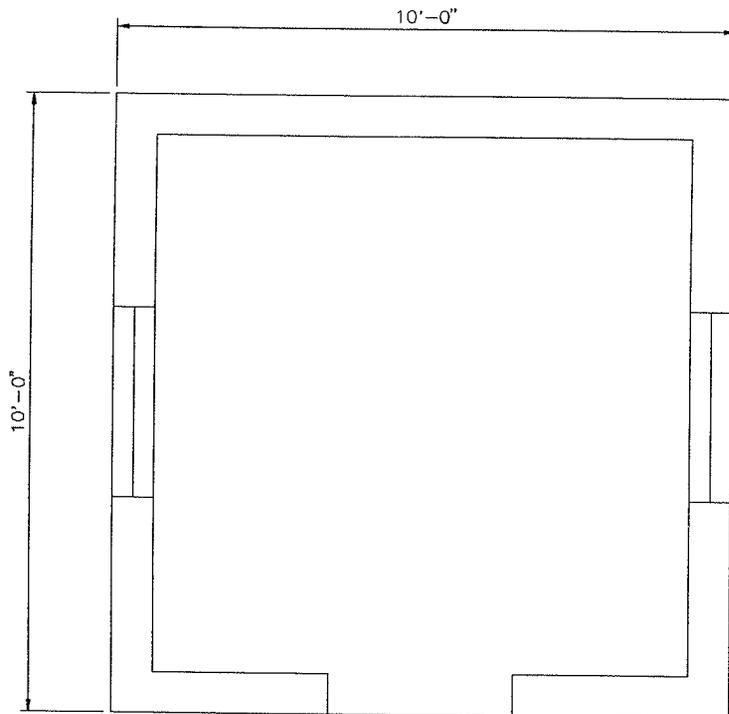
BUILDING # 51-650

51-650, 1, 2, 3  
RS  
5% CHRY

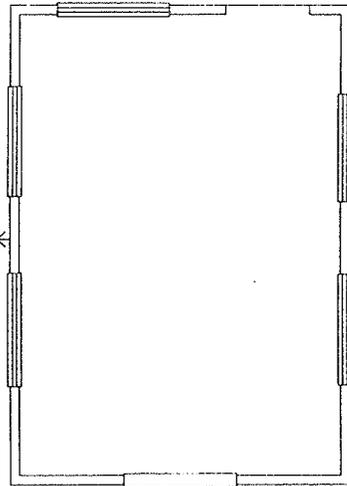
BUILDING # 34-133

34-133-1,2,3  
RS  
NEG

TRANSITE SIDING \*

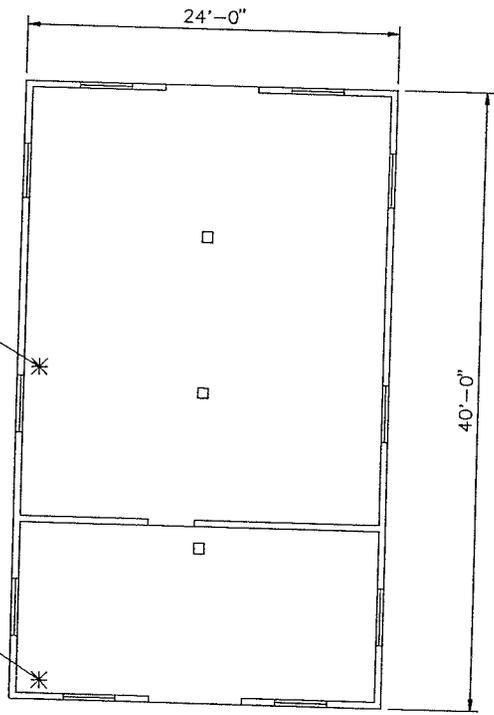
BUILDING # 55-040

55-040-1  
RS  
NEGATIVE

55-040-2  
TR SIDING  
25% CHRY

SIDING SHINGLES CONTAIN ASBESTOS (TRANSITE).

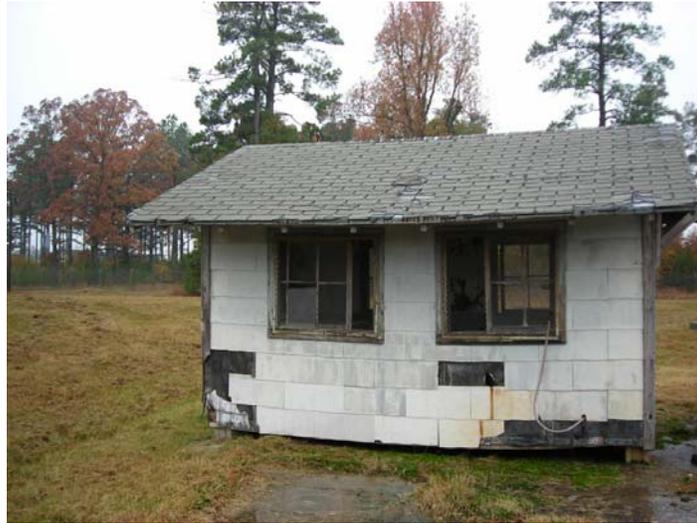
**Building 34-133**

Office equipment and stacked paper remains in Building 34-133 as well as rolls of wire outside the structure.
