Comprehensive Hazardous Material Survey

***At:
WHITE SANDS MISSILE RANGE
BUILDING 21860***

SES Project No. 3N150

**HAZARDOUS MATERIAL SURVEY
WHITE SANDS MISSILE RANGE BUILDING 21860**

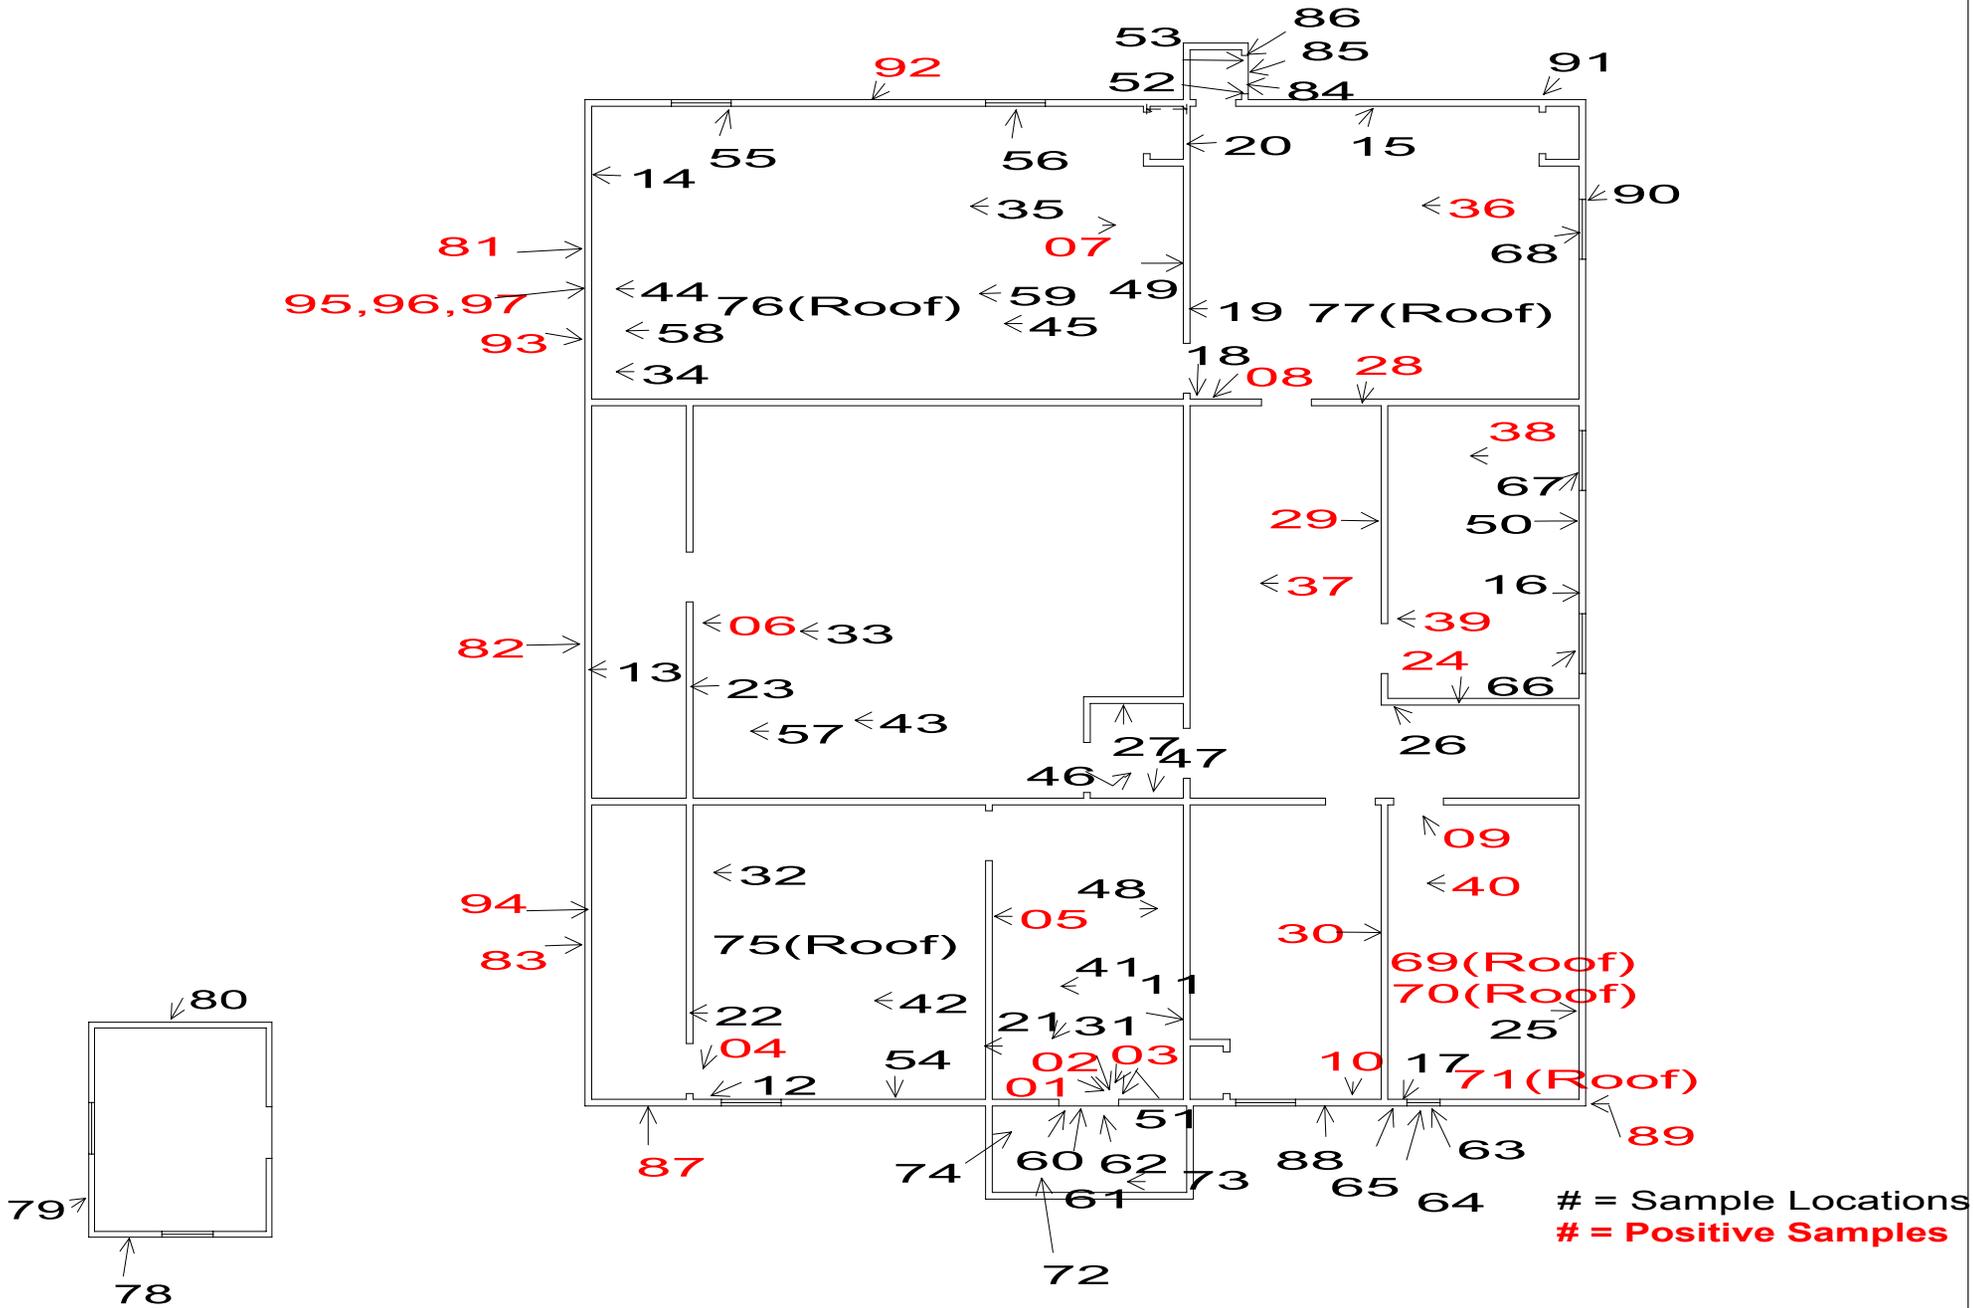
Drawing
 # 1

Asbestos Sample Locations
 Building 21860
 WSMR, N.M.

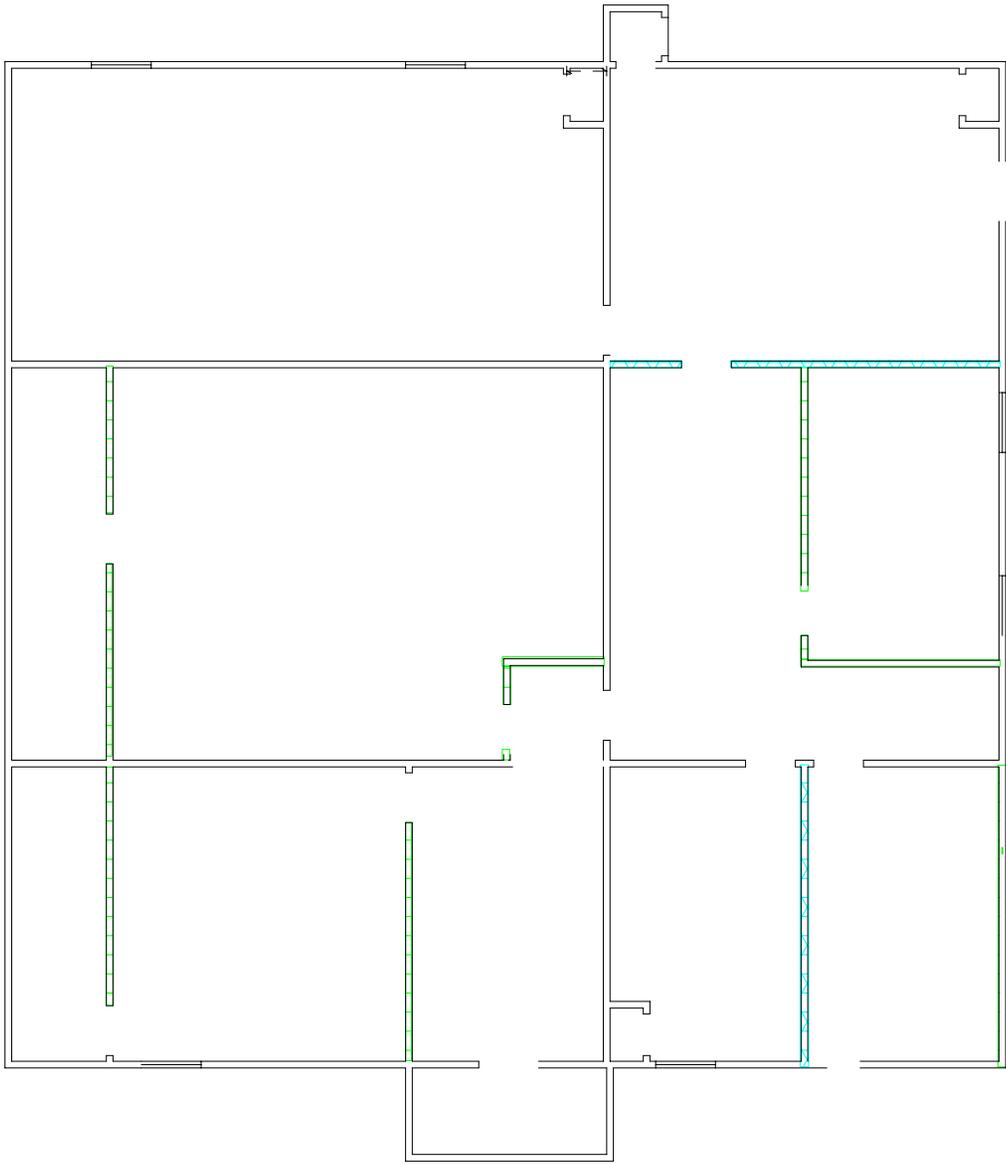
Drawing # 4

= Texture/JC/Wallboard Walls
 = 9"X9" Brown Floor Tile & Mastic

Asbestos Homogeneous Area Locations
 Building 21860
 WSMR, N.M.

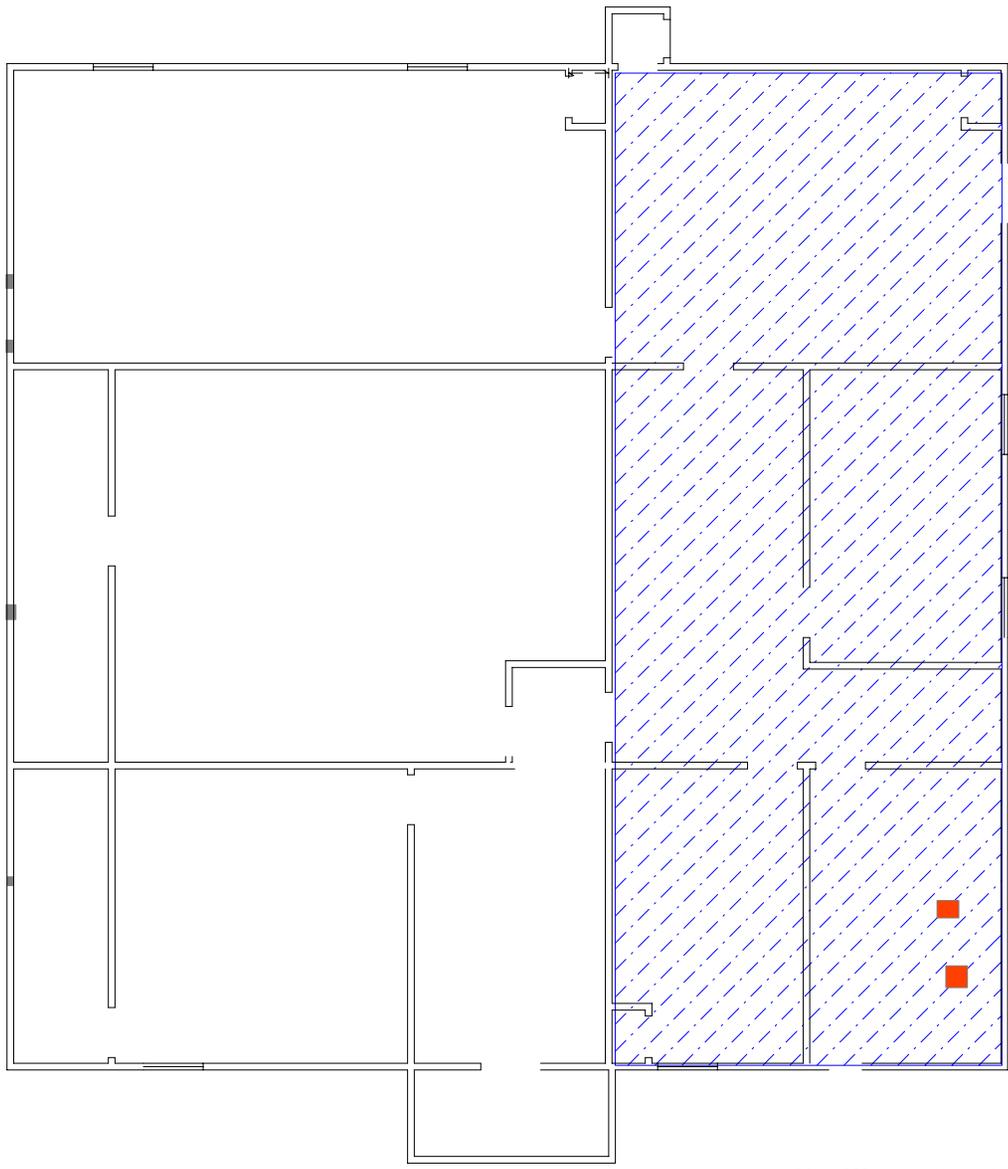
Drawing
 # 5

= Ceiling texture/JC/Wallboard
-

= Wall penetrations
-

= Roof penetration

Asbestos Homogeneous Area Locations
 Building 21860
 WSMR , N.M.

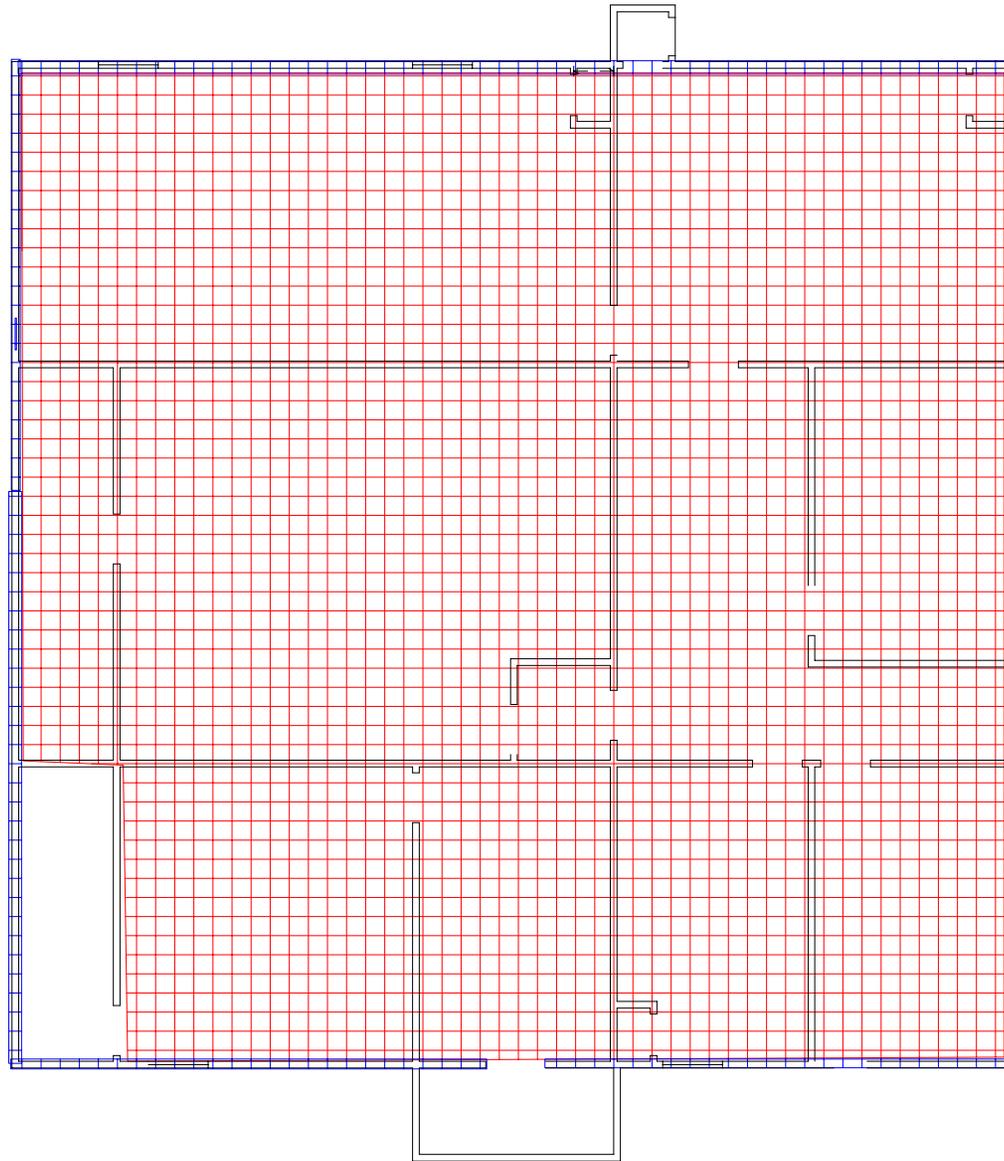
Drawing # 3

= Exterior Stucco Walls
 = 9"X9" Brown Floor Tile & Mastic

Asbestos Homogeneous Area Locations
 Building 21860
 WSMR, N.M.
