***Comprehensive Hazardous
Material Survey***

***At:
WHITE SANDS MISSILE RANGE
BUILDING 21862***

***By:
SAFENET ENVIRONMENTAL SERVICES, LLC.
APRIL 14, 2002***

SES Project No. 3N151

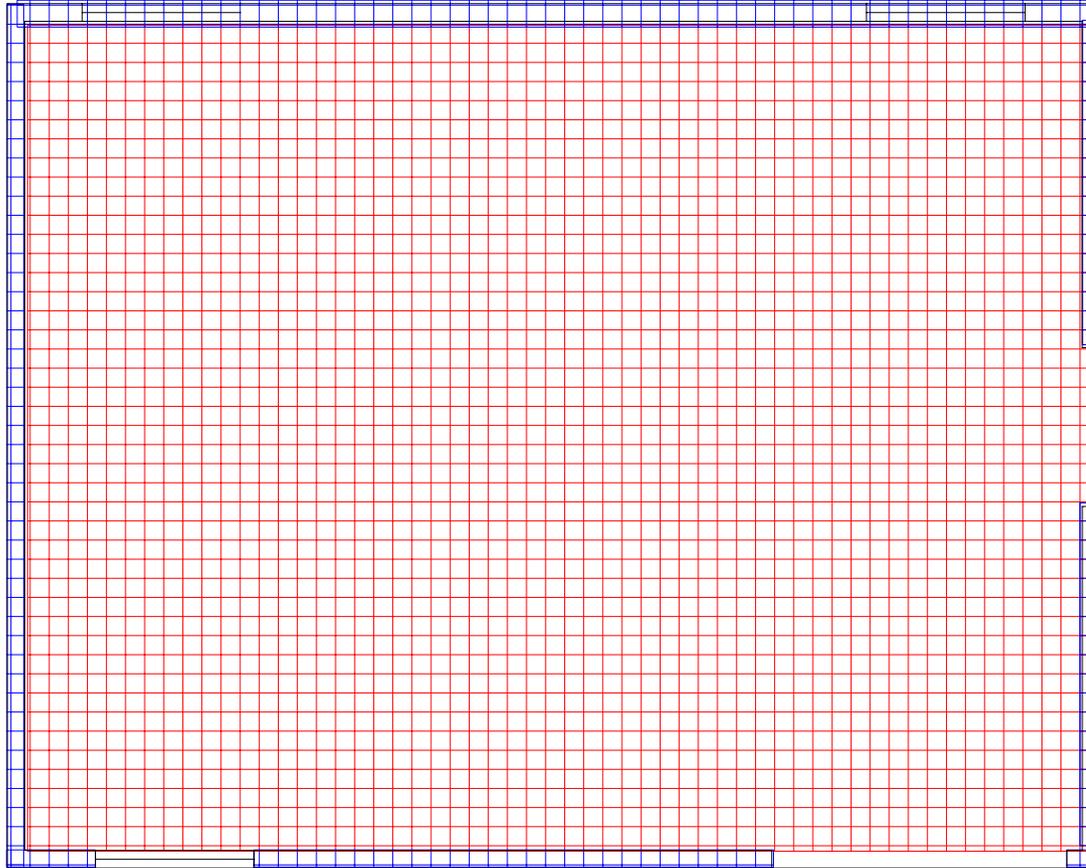
Drawing
 # 2

= 9"X9" Floortile & Black mastic

= Wall Texture

Asbestos Homogeneous Area Locations
 Building 21862
 WSMR , N.M.

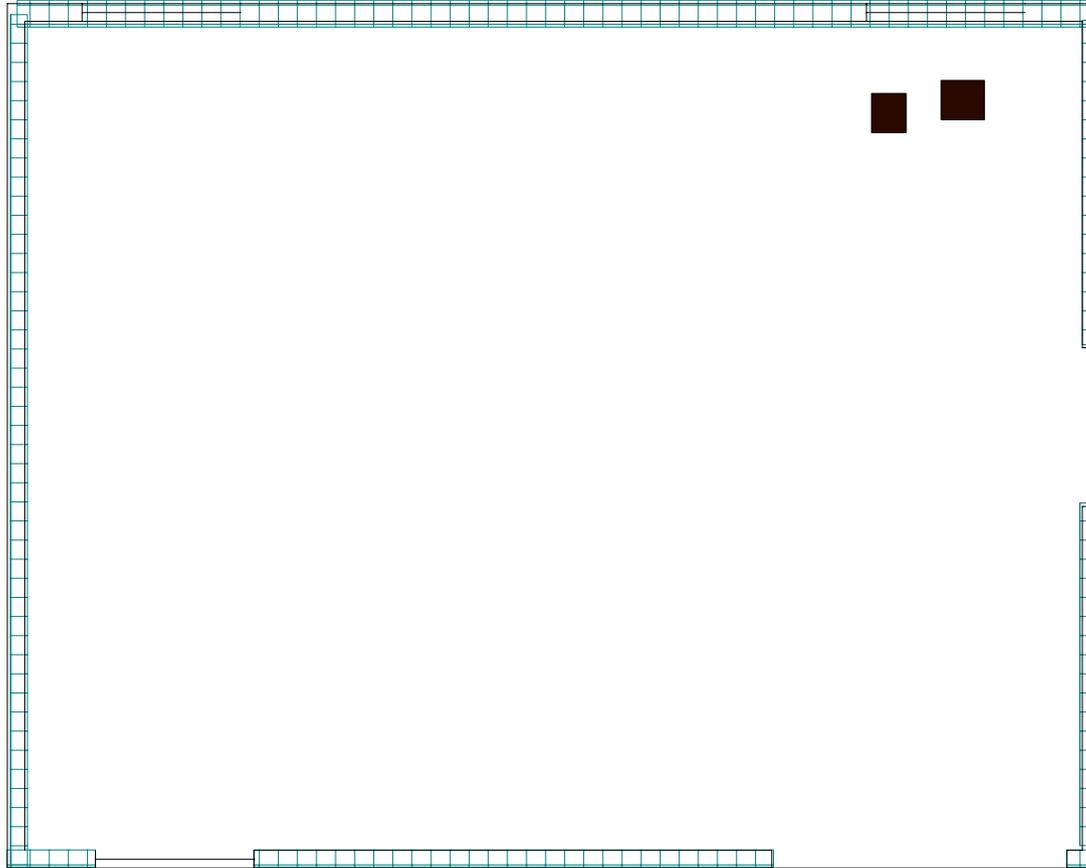
Drawing
 # 3

= Roof Penetrations

= Black Sealant

Asbestos Homogeneous Area Locations
 Building 21862
 WSMR , N.M.

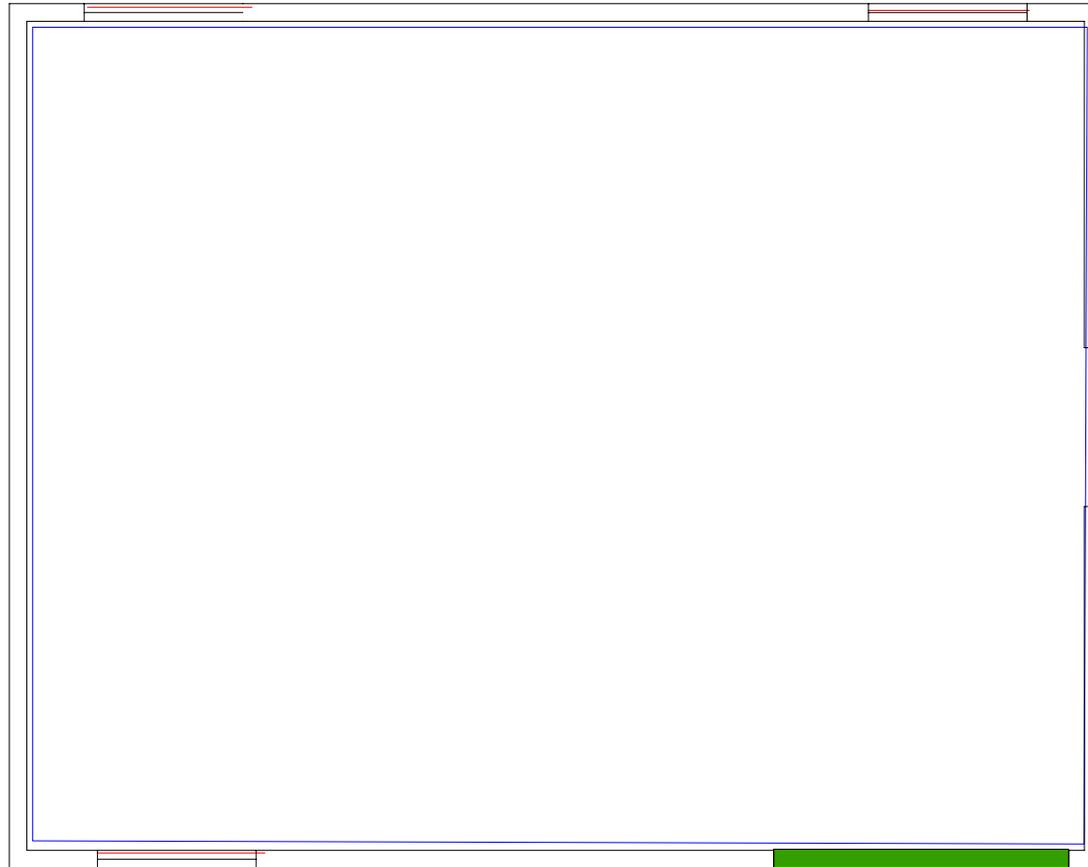
Drawing
 # 5

= **Brown Window Casing**
-

= **Beige Drywall**
-

= **White Doors**
-

= **Yellow Safety Marking on Cement**

Lead Homogeneous Area Locations
 Building 21862
 WSMR , N.M.
