***Comprehensive Hazardous  
Material Survey***

***At:  
WHITE SANDS MISSILE RANGE  
BUILDING 23680***

***SES Project No. 3N152***

**HAZARDOUS MATERIAL SURVEY  
WHITE SANDS MISSILE RANGE BUILDING 23680**

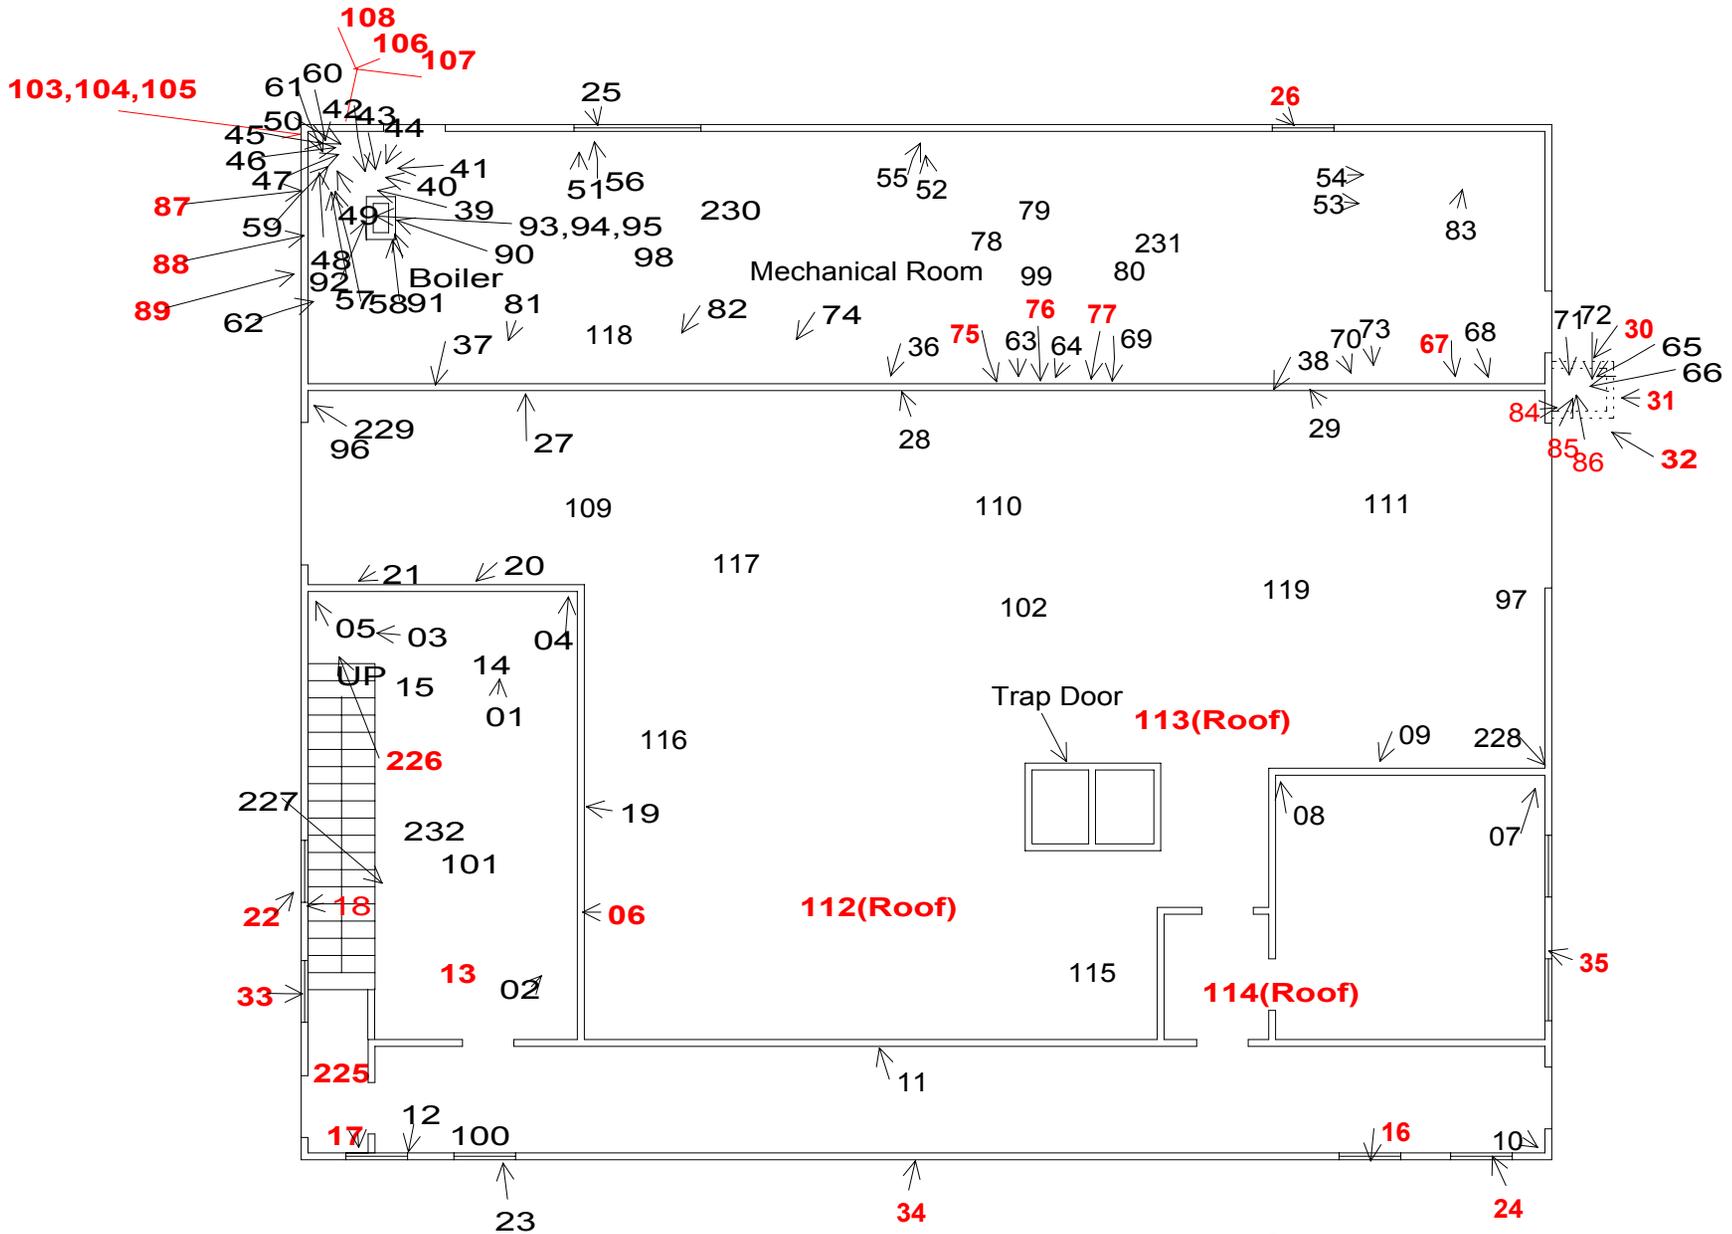
Drawing # 1

Asbestos Sample Locations  
 Building 23680  
 WSMR, N.M.

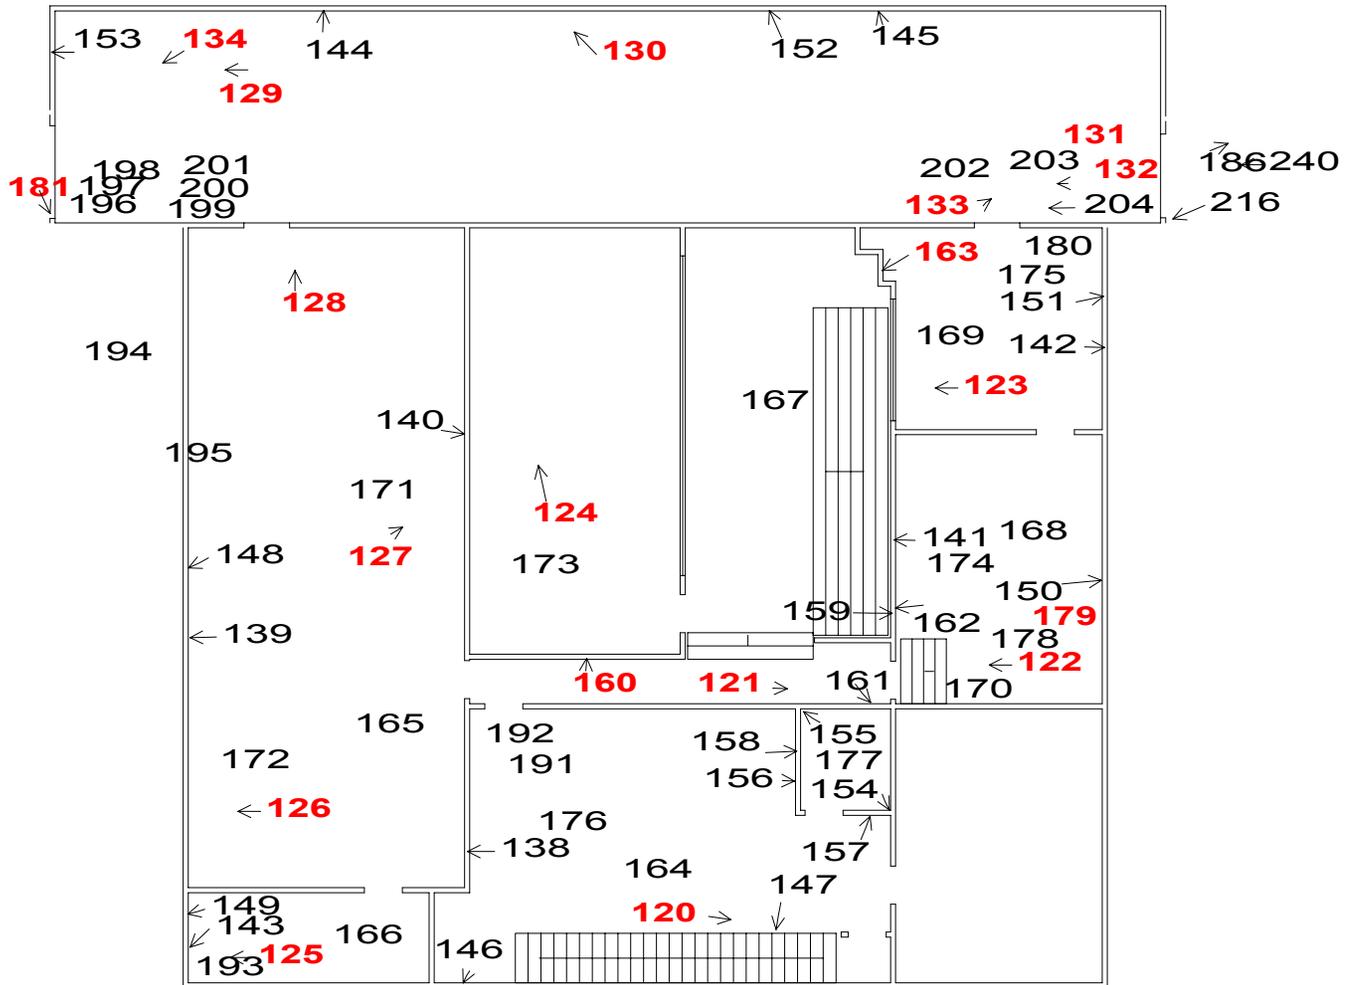
Drawing # 2

Asbestos Sample Locations (Basement)  
 Building 23680  
 WSMR, N.M.

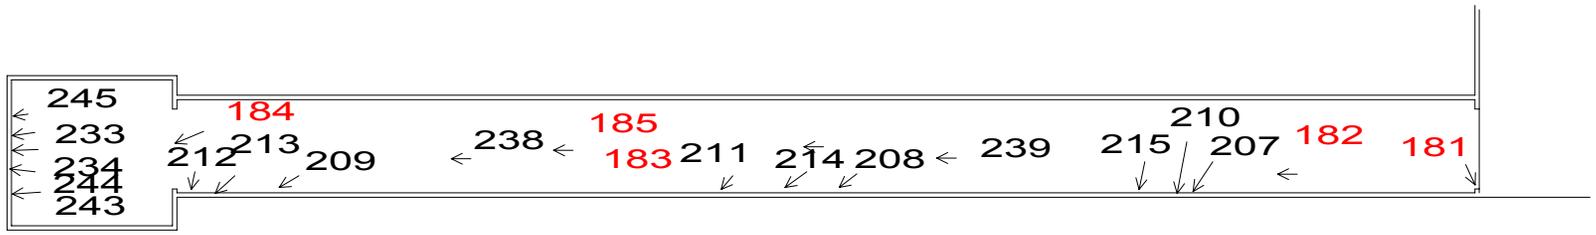
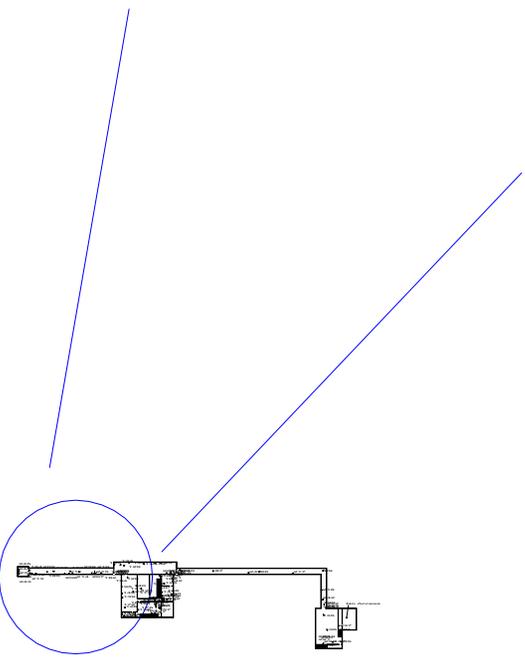
Drawing  
 # 3

Asbestos Sample Locations (Basement W Tunnel)  
 Building 23680  
 WSMR , N.M.

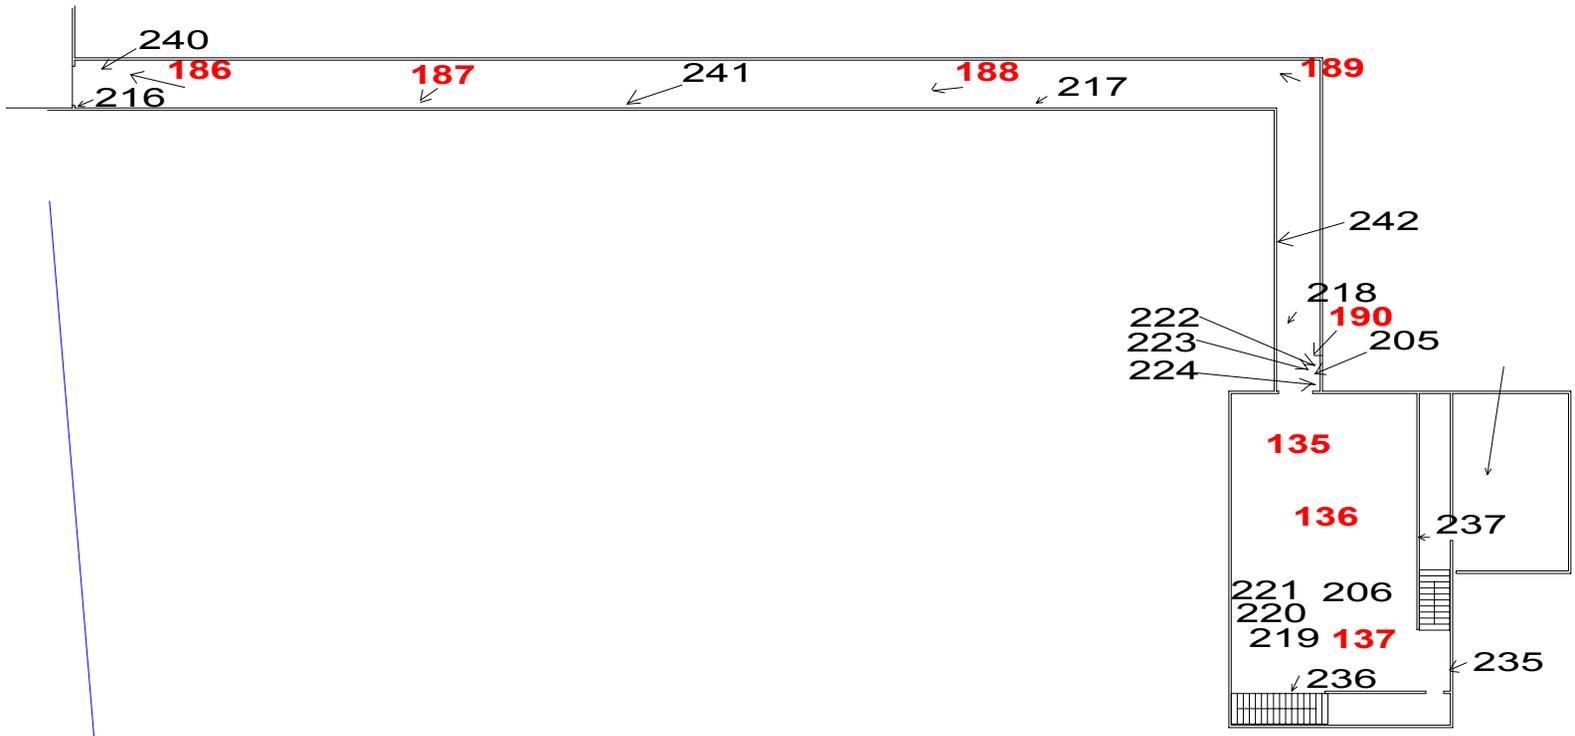
Drawing  
 # 4

Asbestos Sample Locations (Basement E Tunnel)  
 Building 23680  
 WSMR , N.M.

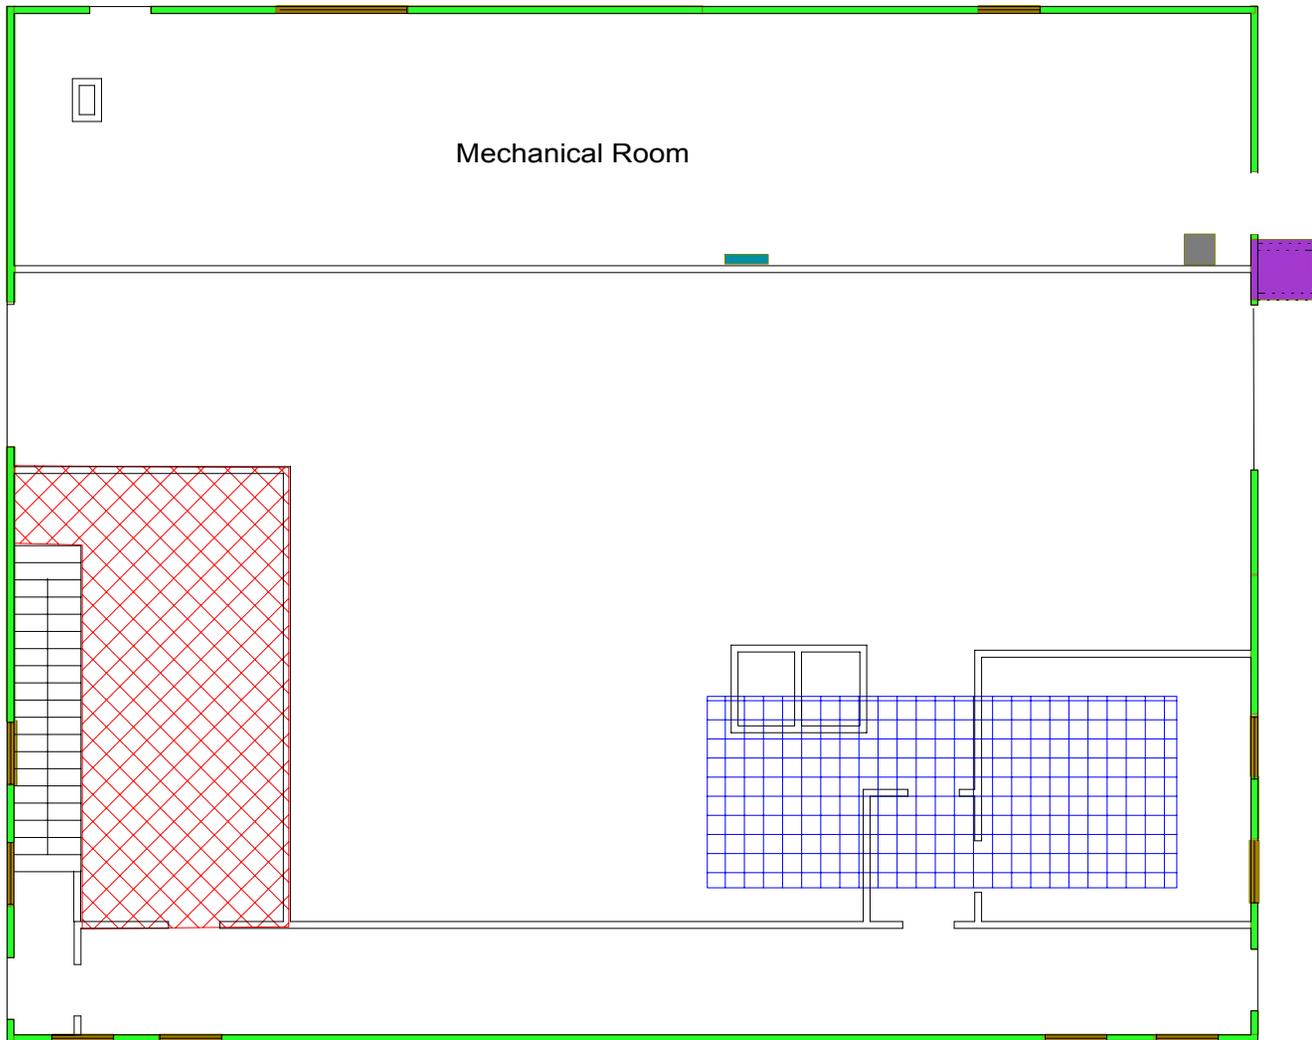
Drawing # 5

Homogeneous Area Locations  
 Building 23680  
 WSMR, N.M.

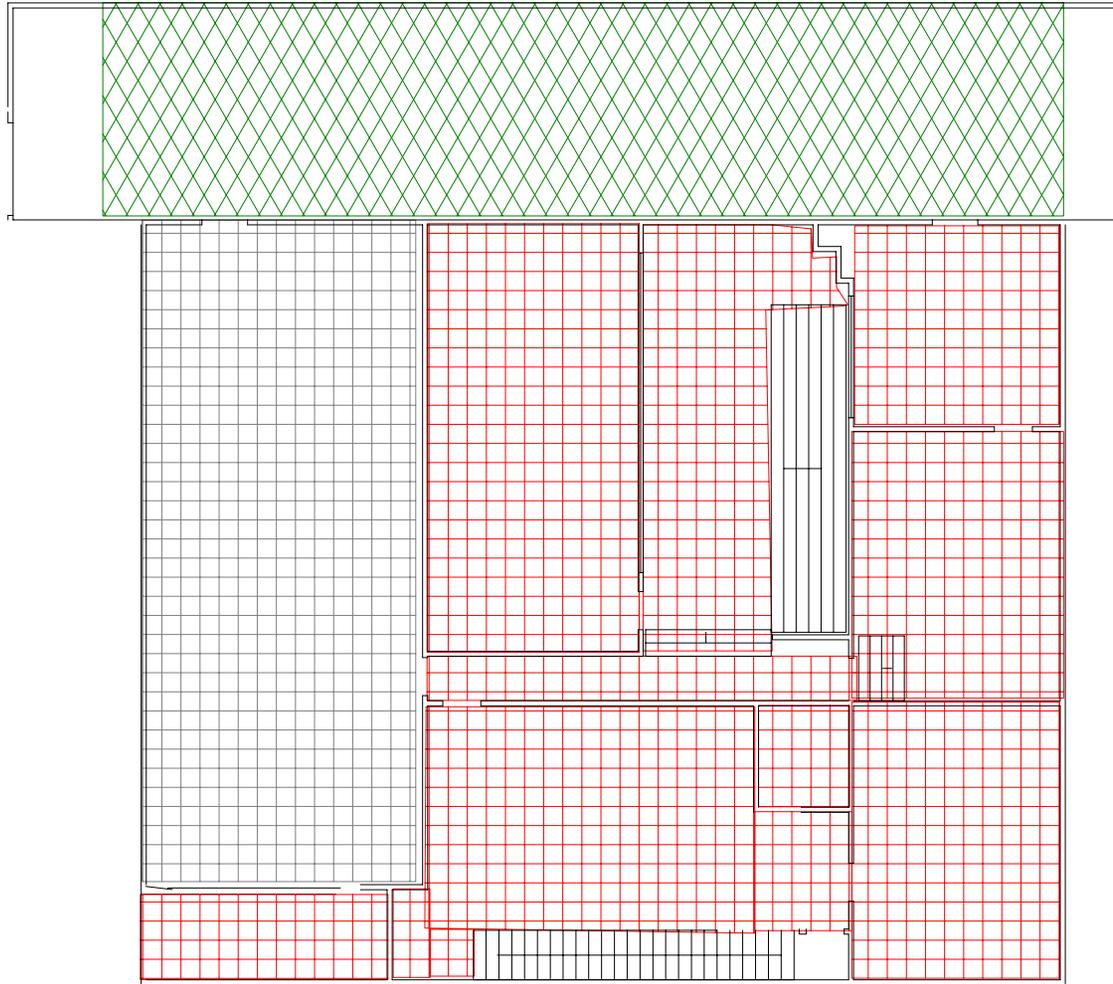
Drawing  
 #6

Homogeneous Area Locations  
 Building 23680  
 WSMR , N.M.

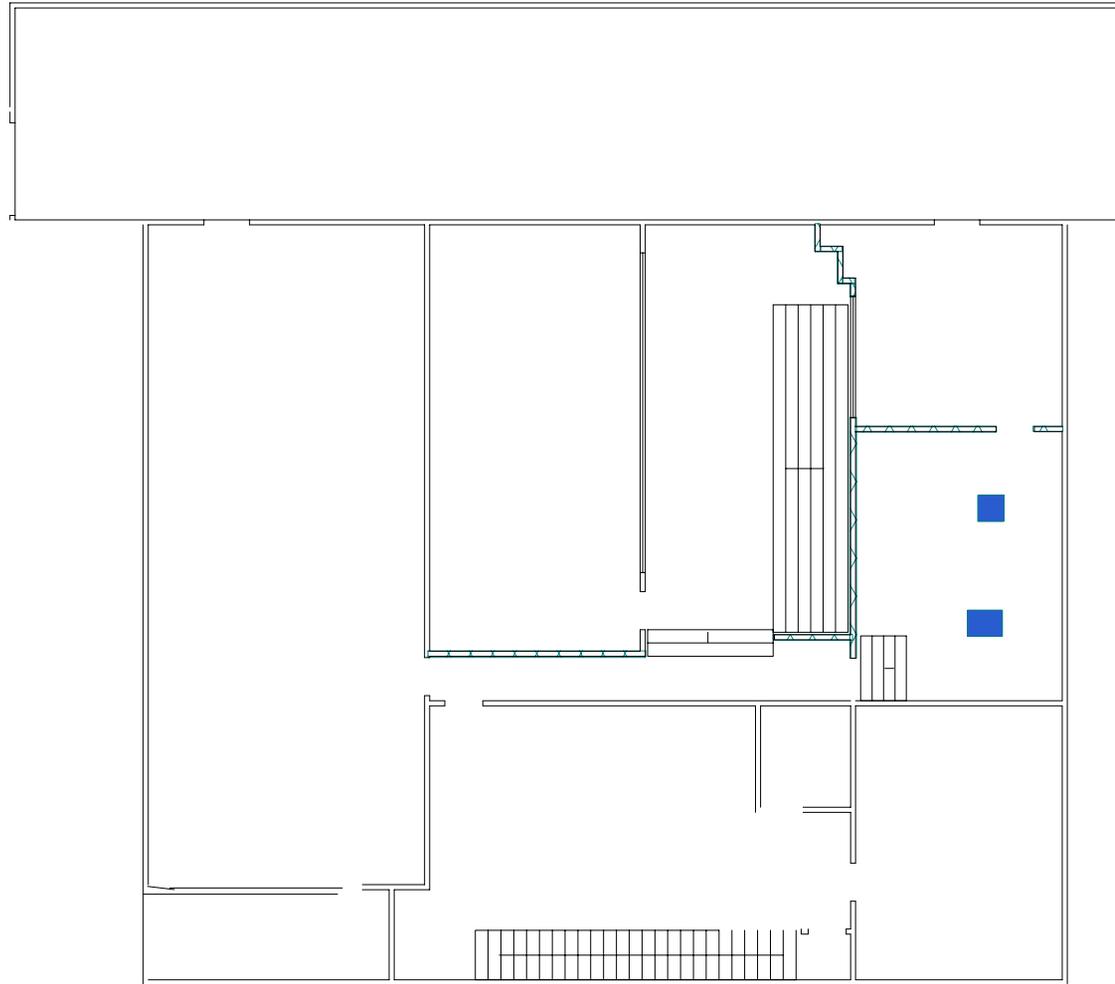
Drawing  
 #7

Homogeneous Area Locations  
 Building 23680  
 WSMR , N.M.

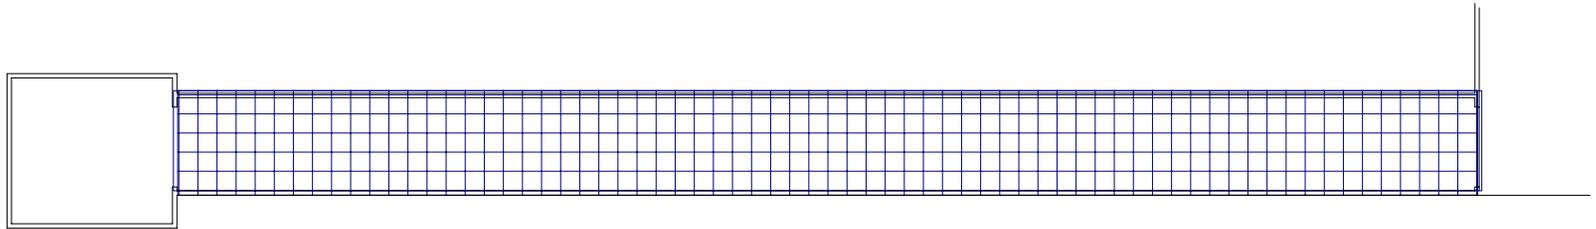
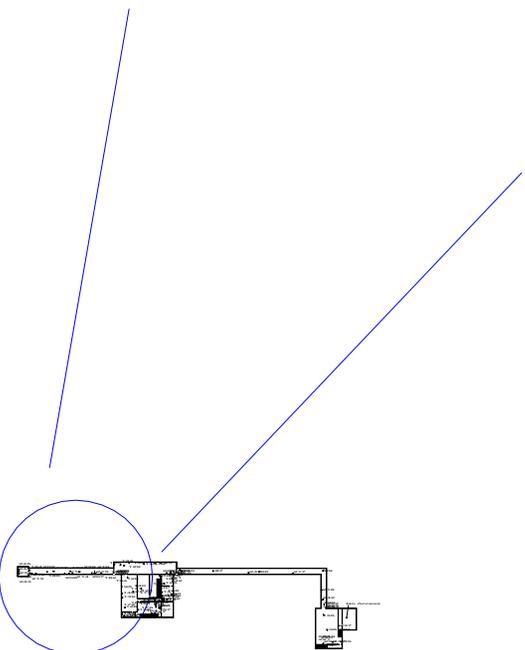
Drawing  
 # 8

Homogeneous Area Locations-5 (Basement W Tunnel)  
 Building 23680  
 WSMR , N.M.

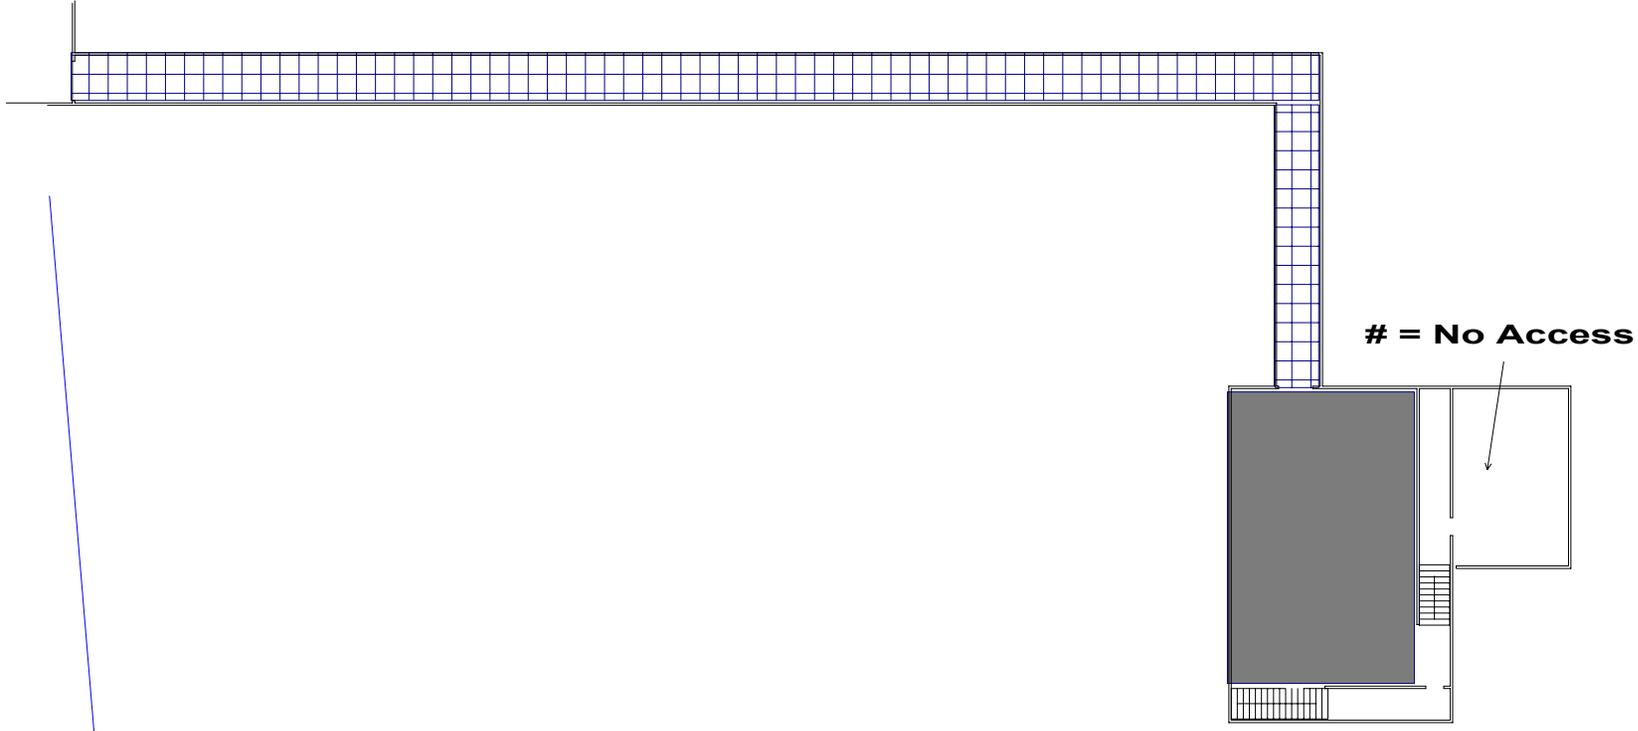
<p><b>SafeNet</b> Environmental Services LLC 3945-F Doniphan Park Circle El Paso, Texas 79922 (915) 587-6900</p>	<p>Drawing # 9</p>	<p>Homogeneous Area Locations-6 (Basement E Tunnel) Building 23680 WSMR , N.M.</p>
