ERDC/CERL TR-07-2

LBP Concerns in Producing Recycled Concrete Aggregate from Former Fort Ord Family Housing

Final report

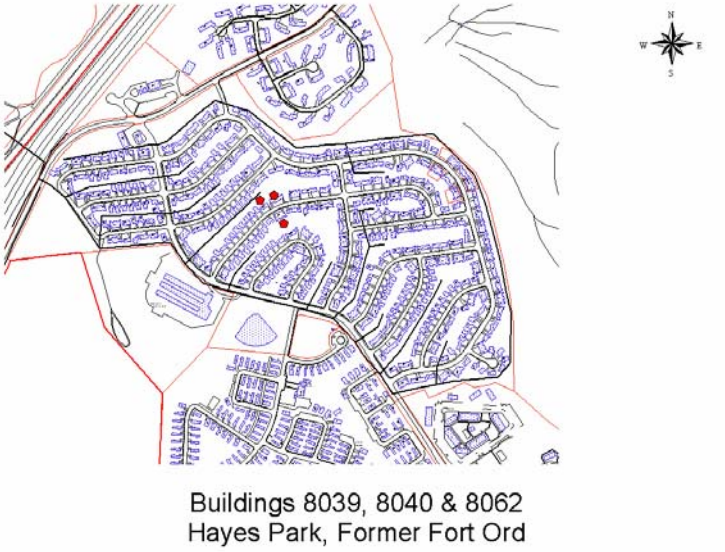
Figure 2. Hayes Park Army family housing.

Three sample structures were chosen to study their LBP content. They were some of the last units to be demolished under the redevelopment project, and had already been stripped down to concrete walls. Two of these were duplex family housing units. The addresses were 223, 225-227, and 226-228 Napier Street. Figure 2 shows a map of the Hayes Park neighborhood. The numbers on the map are the Army real property building numbers. This report uses the common street addresses. Figure 3 shows a typical building in this neighborhood.

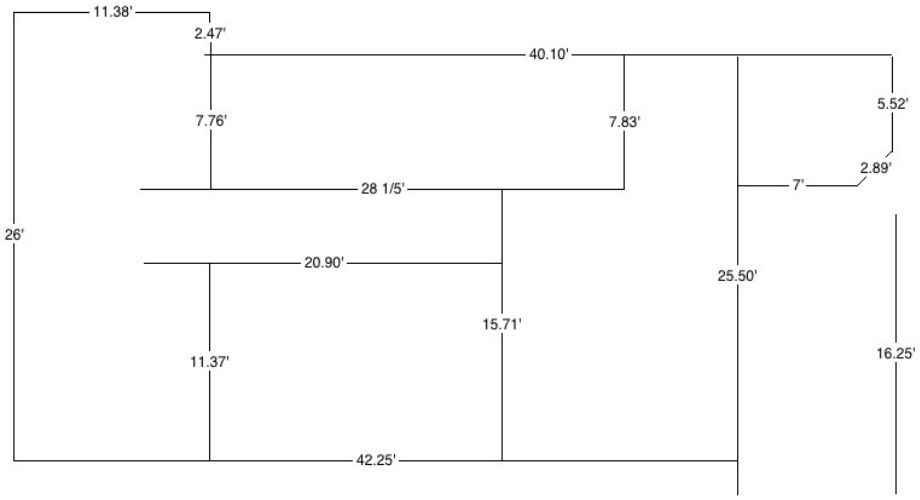
Figure 10. Line drawing of 223 Napier Street.

Figures 10, 11, and 12 show line drawings of buildings 223, 224, and 225 Napier Street based on field measurements. House 224 is half of a duplex with 226; 225 is duplexed with 227. Each side is a mirror image. It is assumed that paint measurements for building 224 will be valid for 226.
