Comprehensive Hazardous Material Survey

At:
WHITE SANDS MISSILE RANGE
BUILDING 21610
PREPARED FOR:
MS. ANN HOFFMAN
MR. GERRY ARVIZO
WHITE SANDS MISSILE RANGE
W SMR, NM

BY:
SAFENET ENVIRONMENTAL SERVICES, LLC
AUGUST 2 , 2002

HAZARDOUS MATERIALS SURVEY
FOR BUILDING 21610
WHITE SANDS MISSILE RANGE

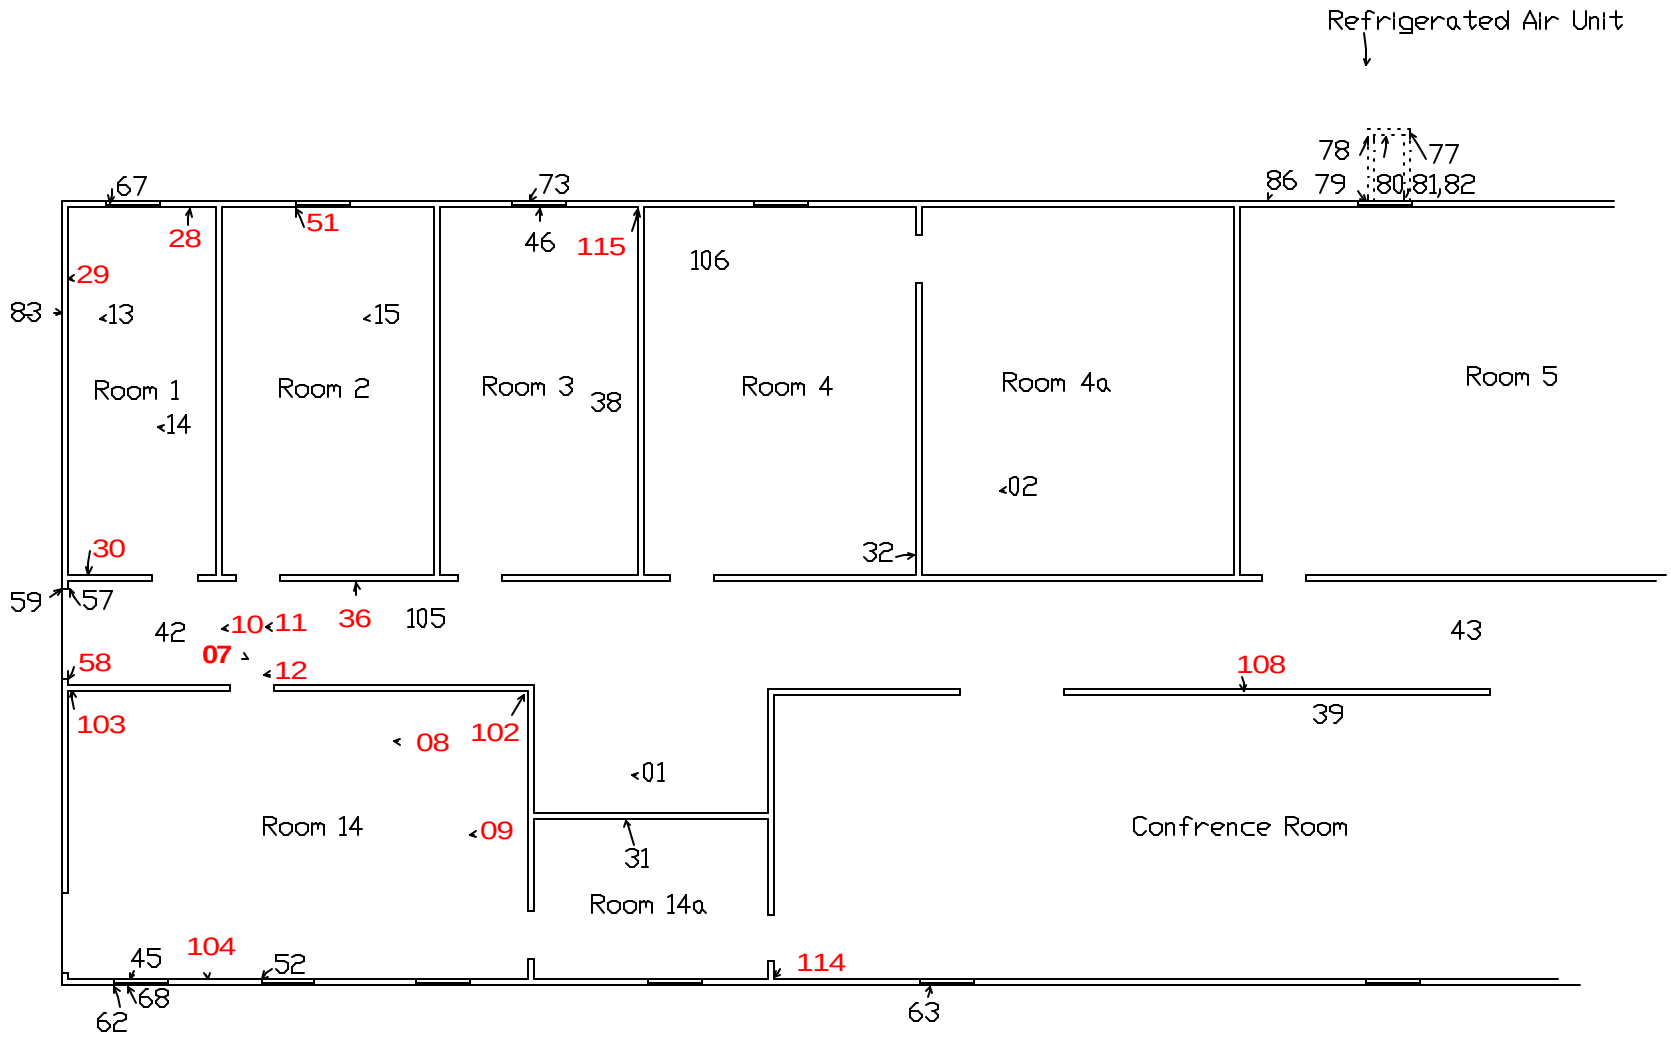
Asbestos Sample Locations
bldg 21610-1st Floor North End
WSMR, NM

= Positive Asbestos Locations

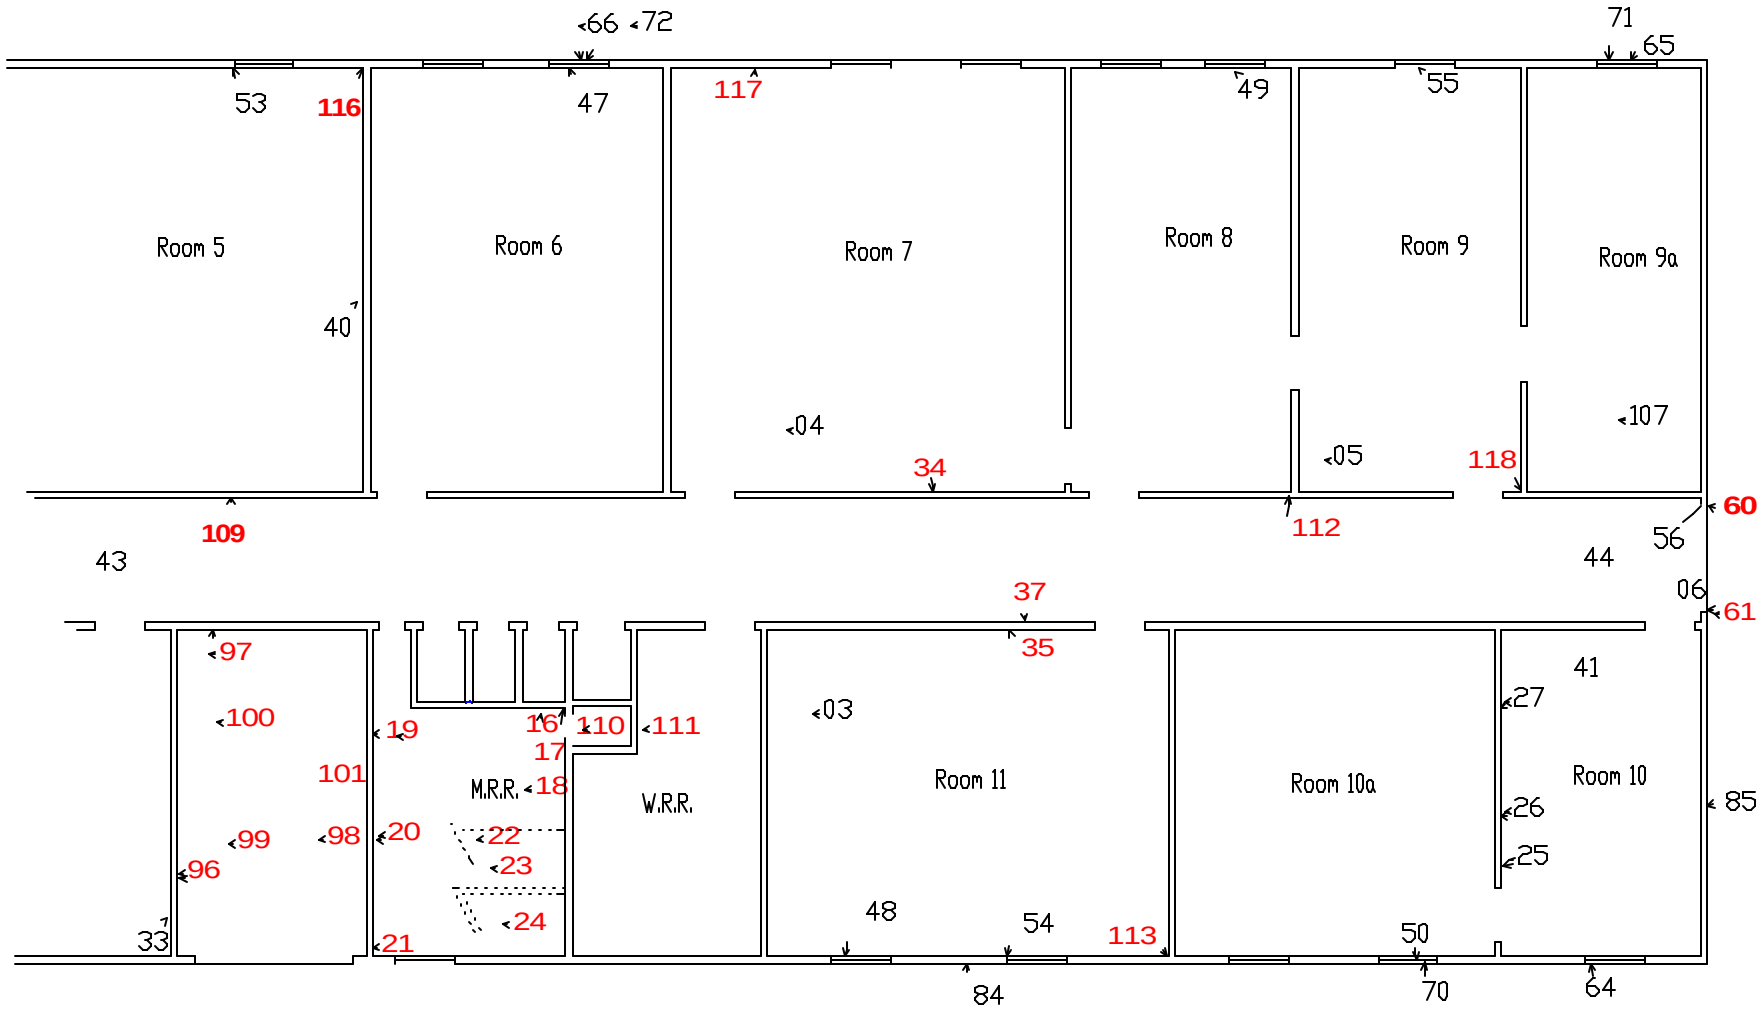
Asbestos Sample Locations
Bldg 21610- 1st Floor South End
WSMR, NM

= Positive asbestos locations

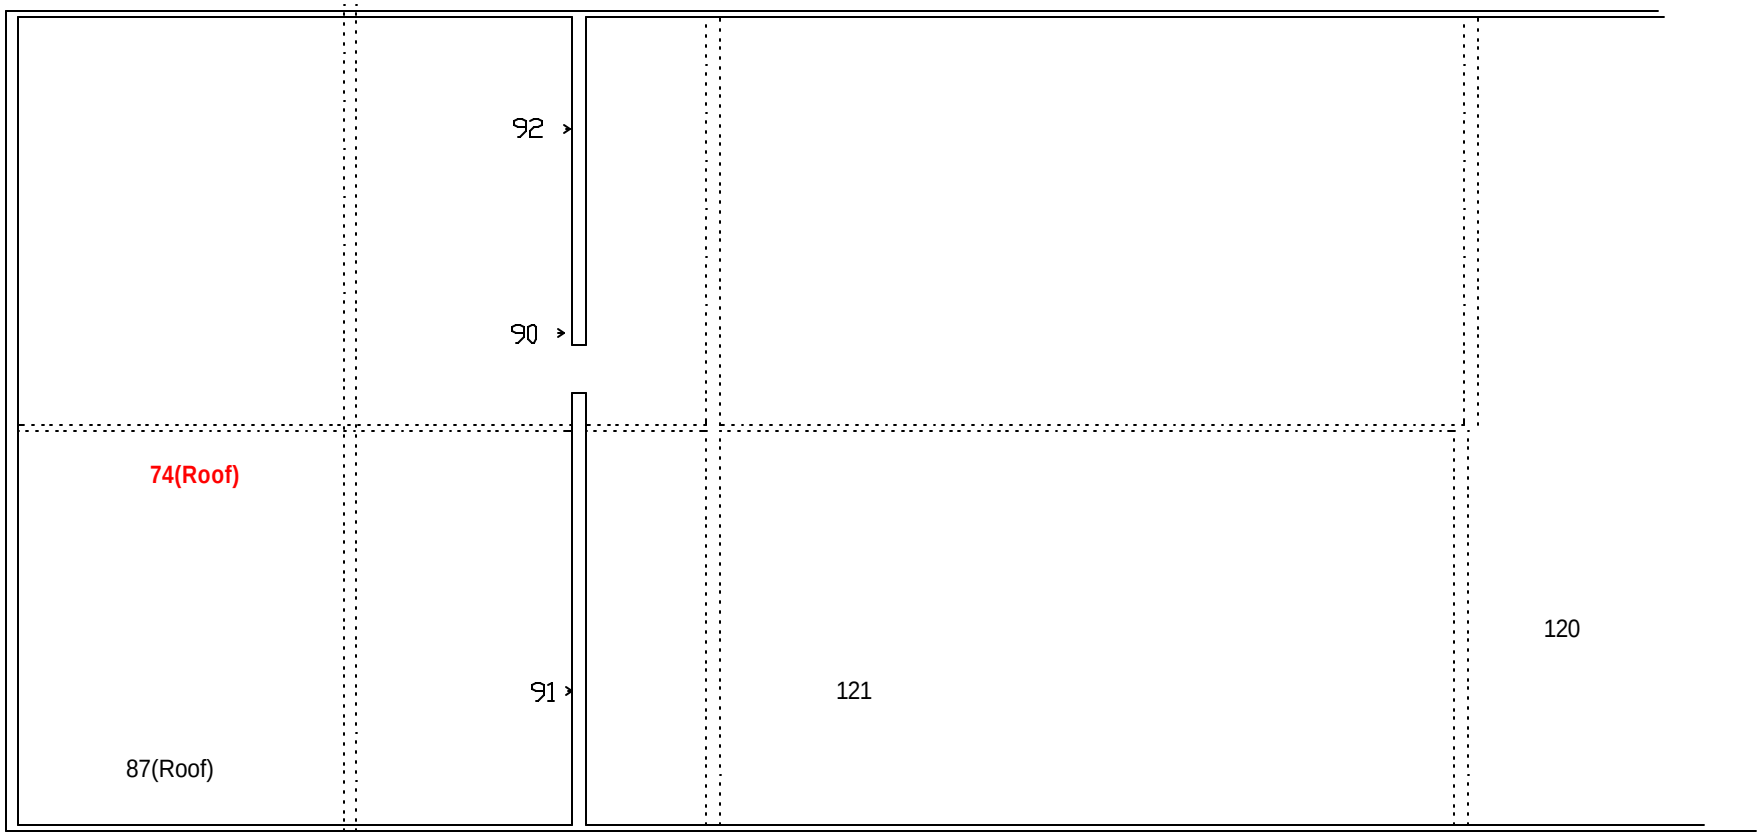
Asbestos Sample Locations
bldg 21610-Attic, North End
WSMR, NM

= Positive Asbestos Locations

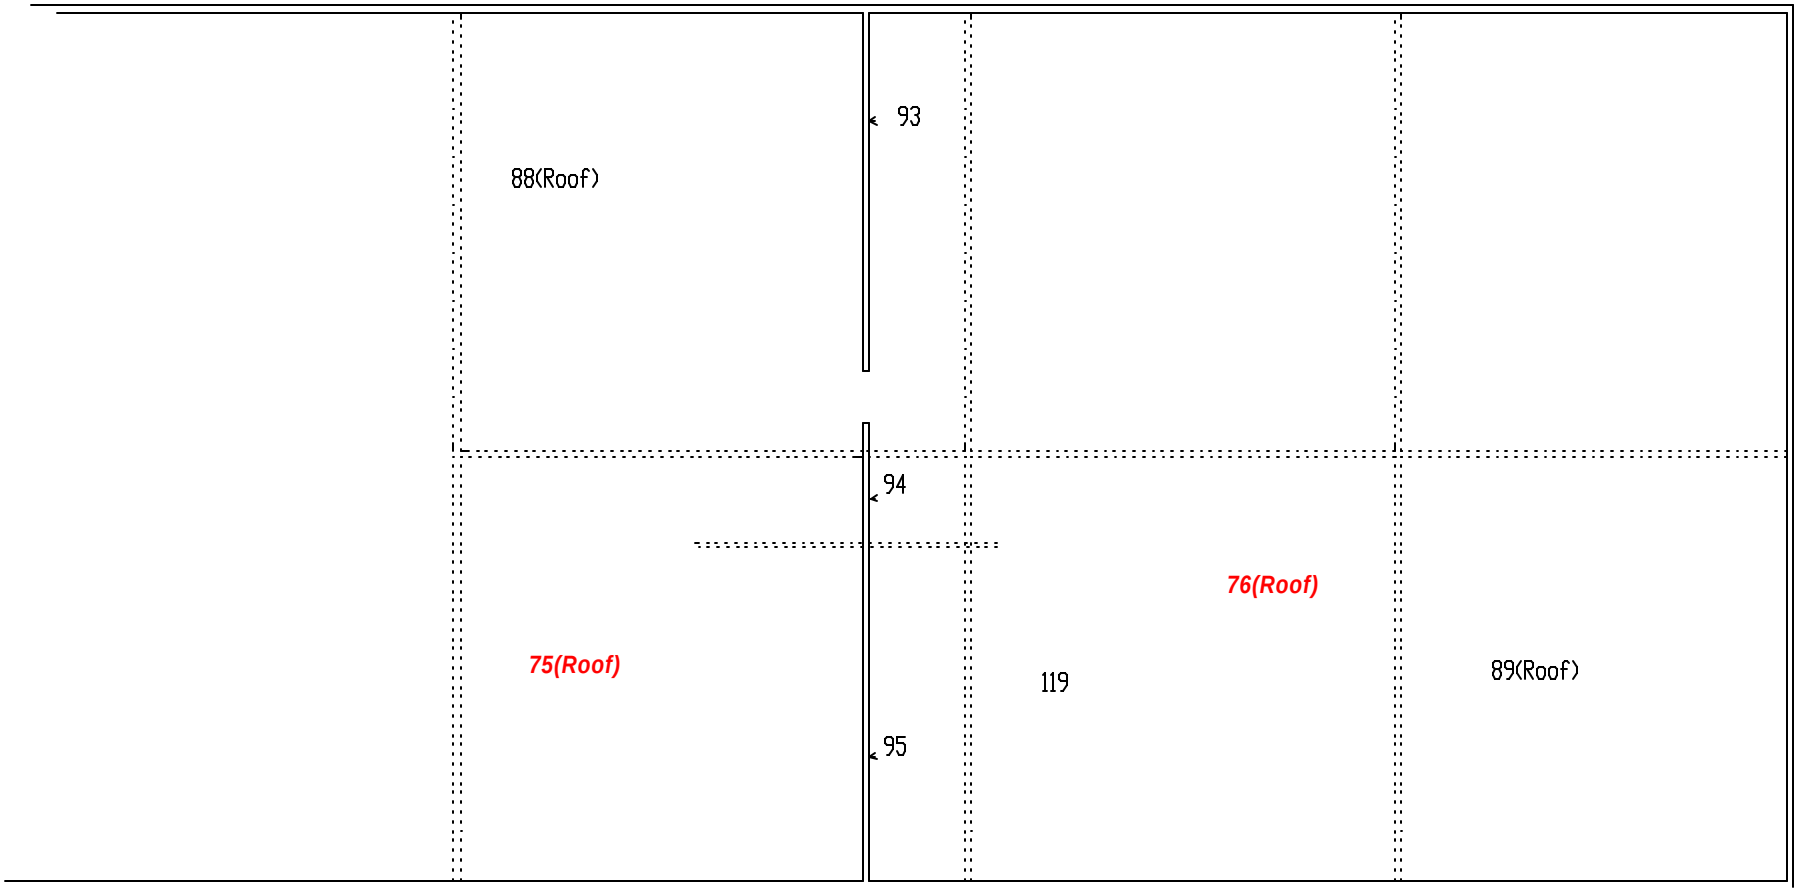
Asbestos Sample Locations
bldg 21610-Attic, South End
W.S.M.R., N.M.

= Positive Asbestos Locations

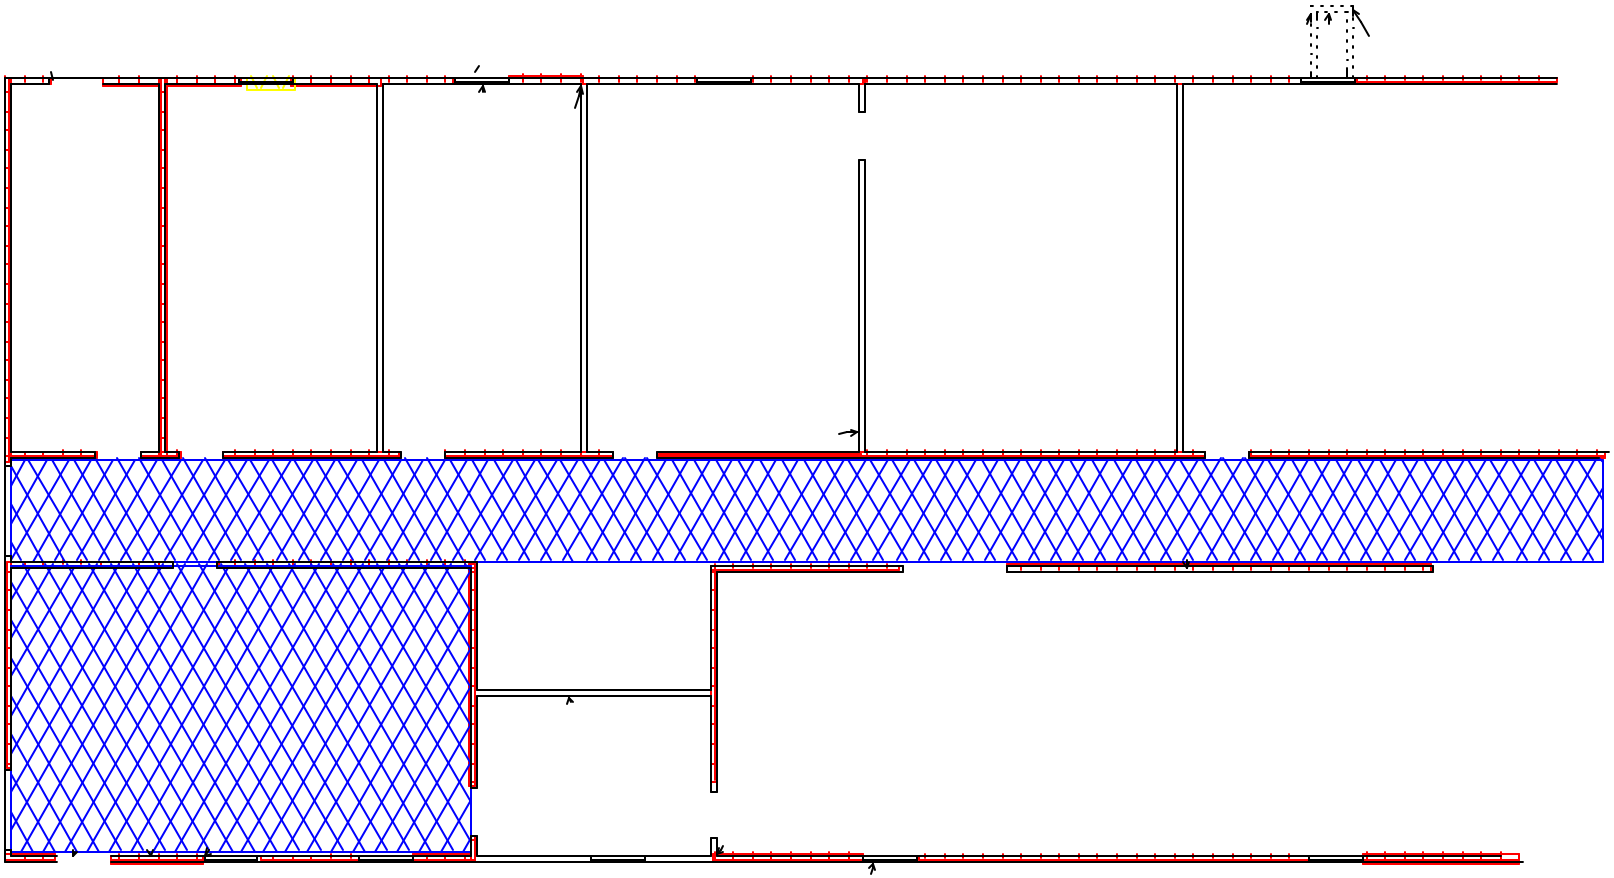
Asbestos Homogeneous Locations
bldg 21610-North End
WSMR, NM

= Positive texturing compound

=Positive floor tile mastic

=Positive window caulking

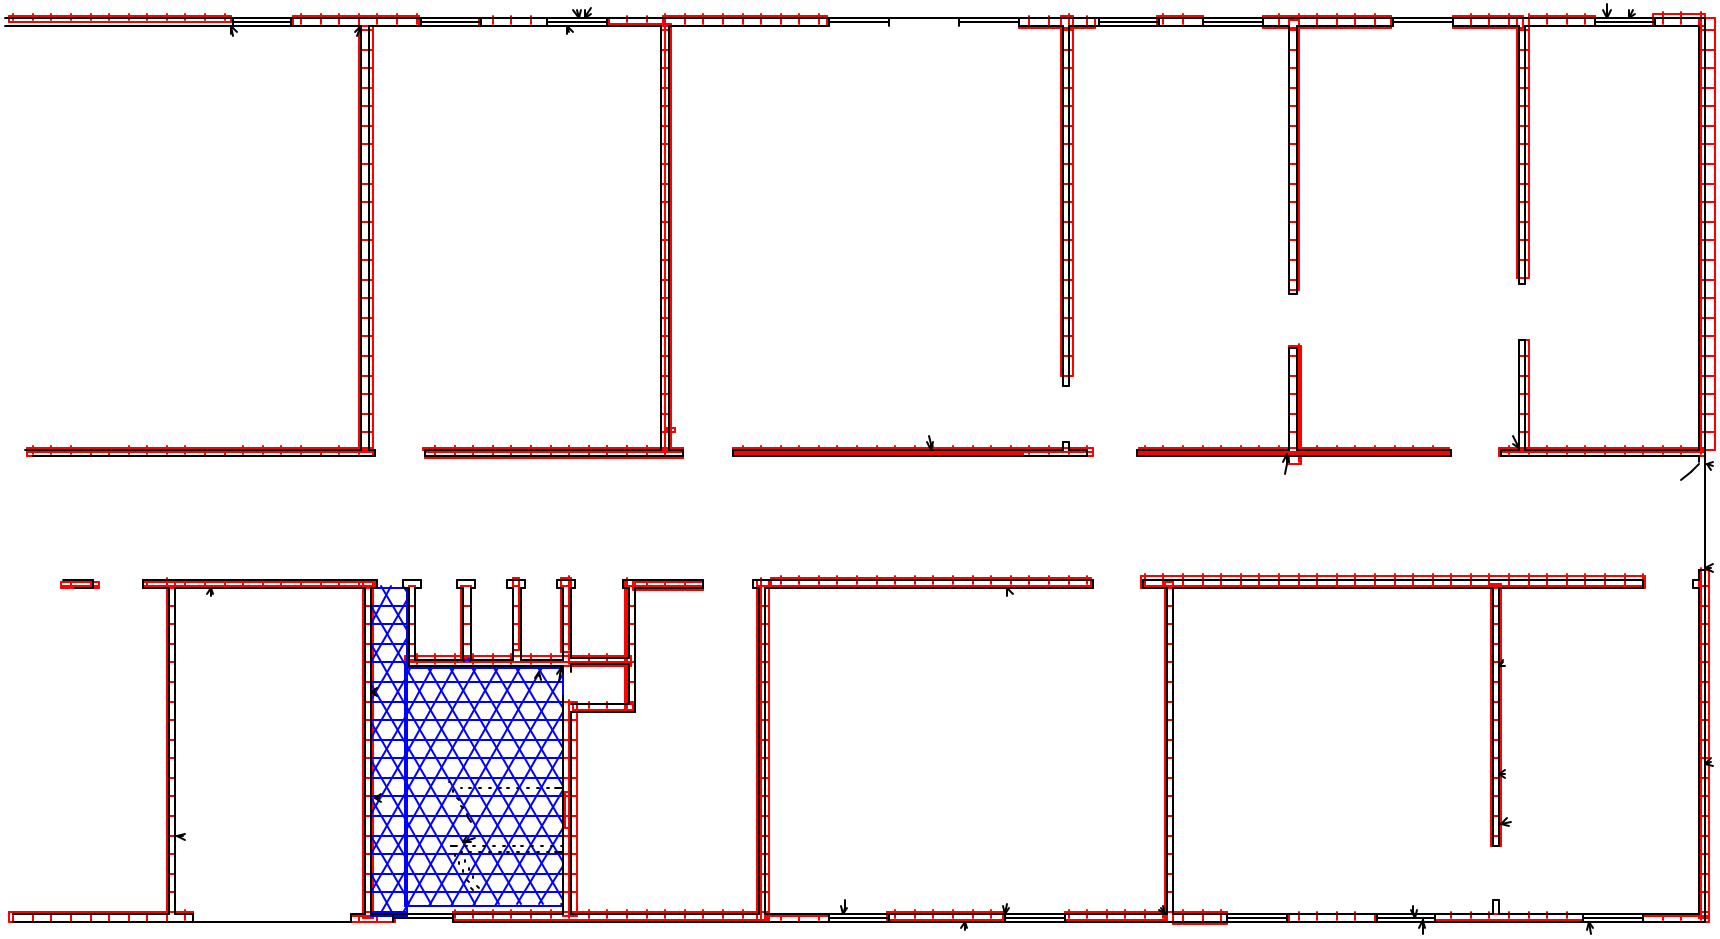
Asbestos Homogeneous Locations
bldg 21610- 1st Floor South End
WSMR, NM

= Positive texturing compound

= 9*9 Floor tile and mastic

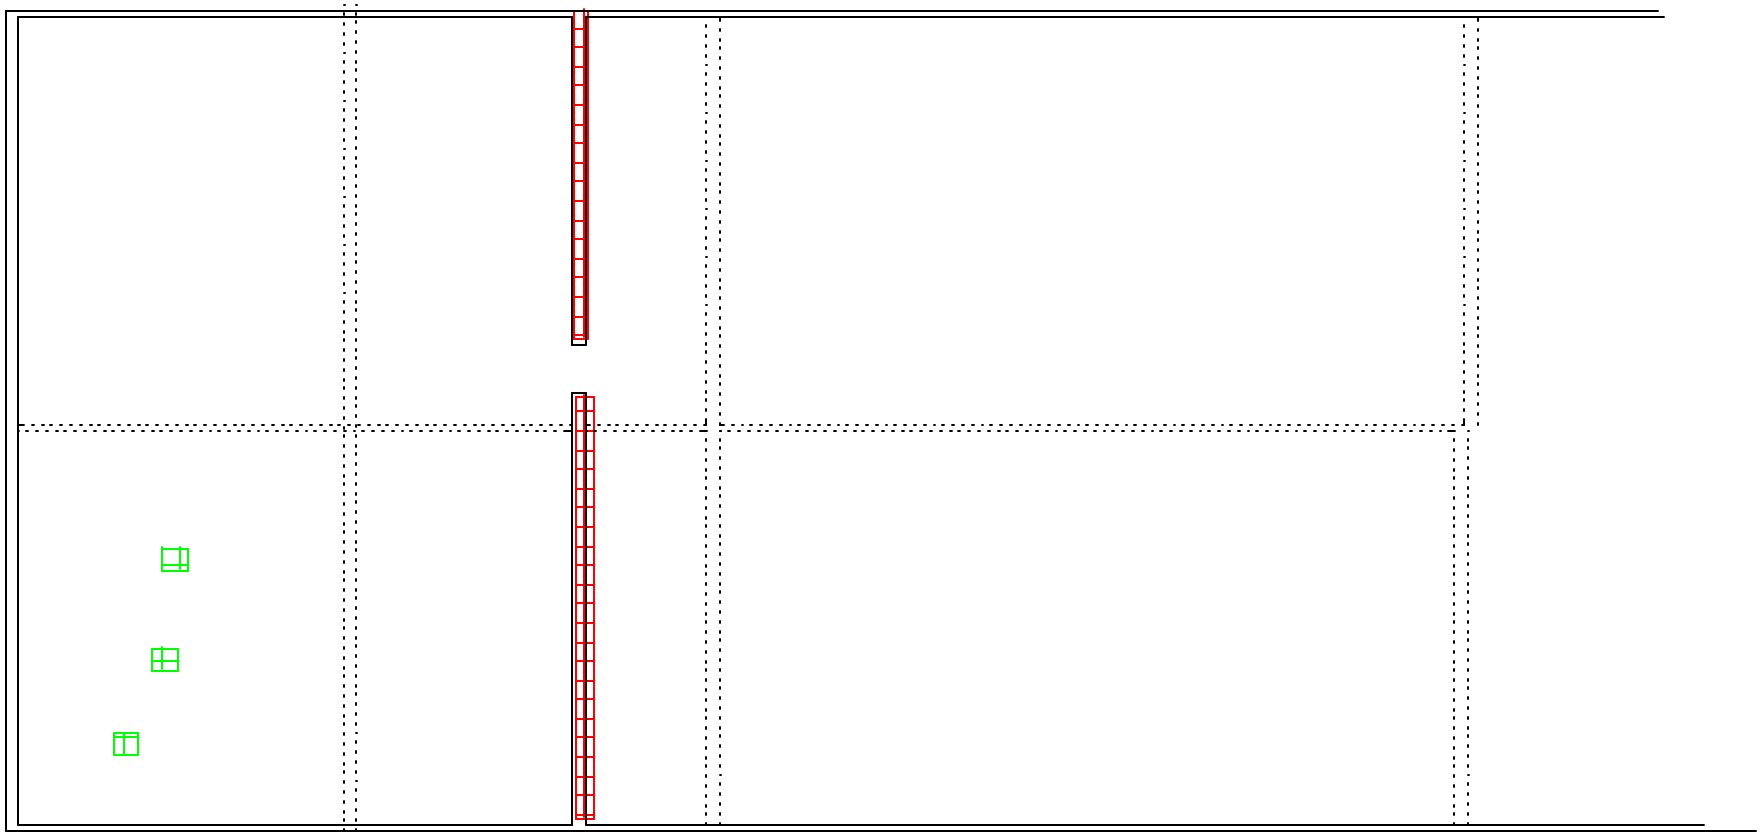
Asbestos Homogeneous Locations
bldg 21610-North End, Attic
WSMR, NM

= Positive terturing compound Locations

=Roof penetration(s)

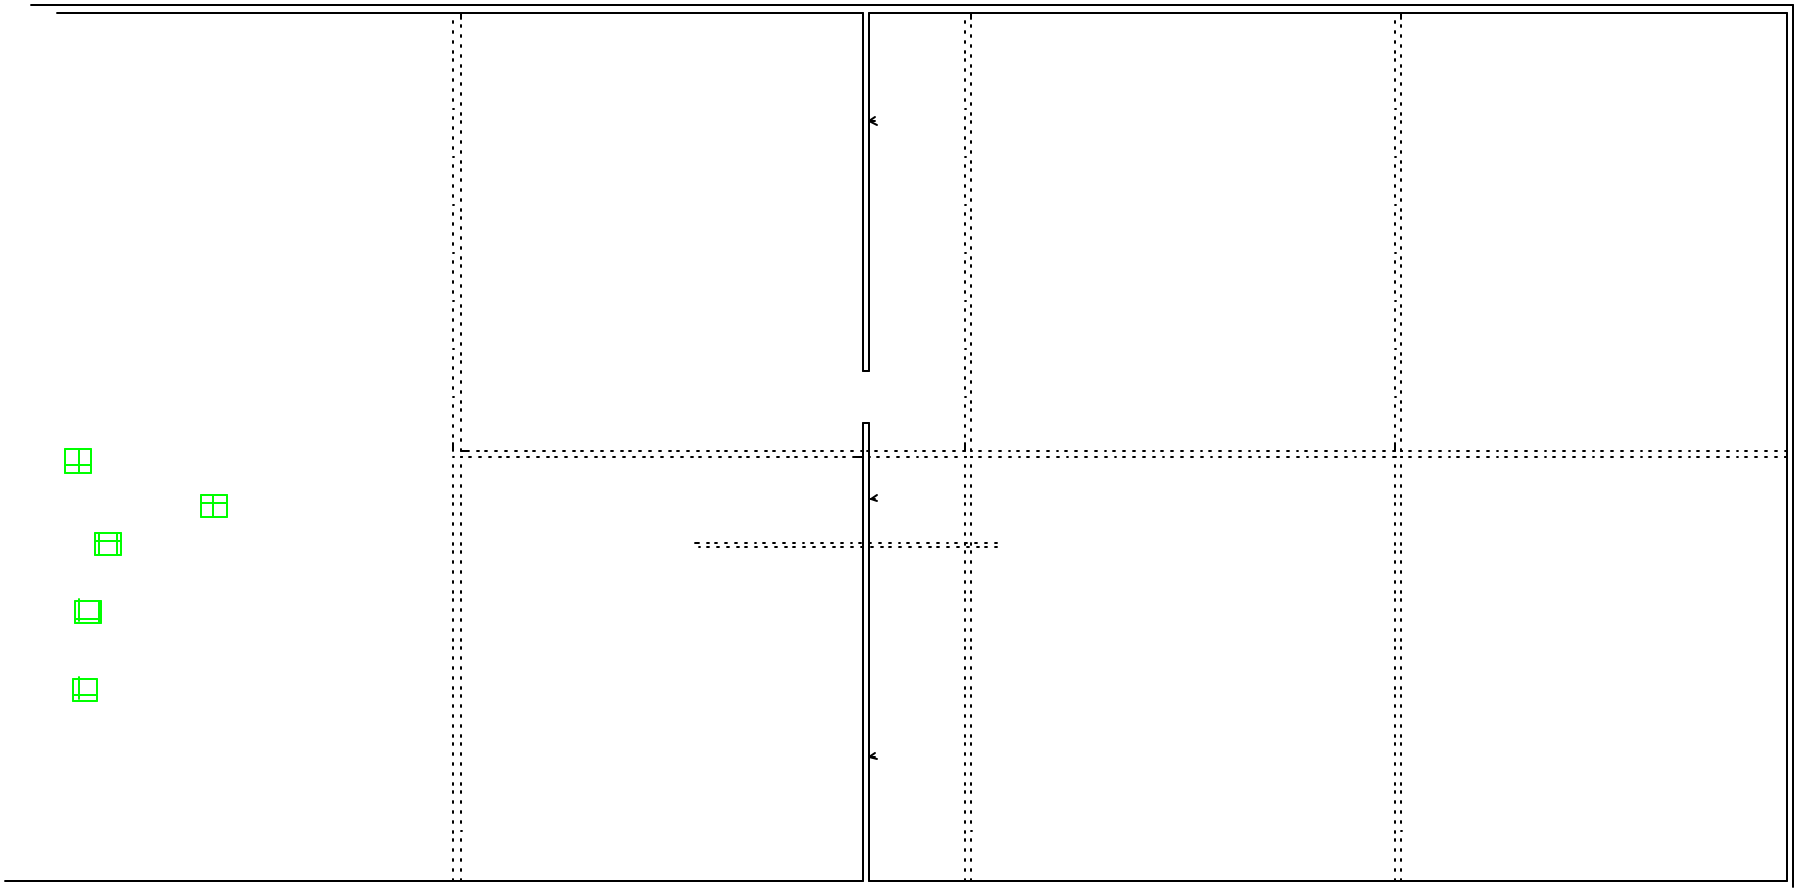
Asbestos Homogeneous Locations
bldg 21610-Attic, South End
W.S.M.R., N.M.

= Asbestos Homogeneous Locations
Roof penetration(s)

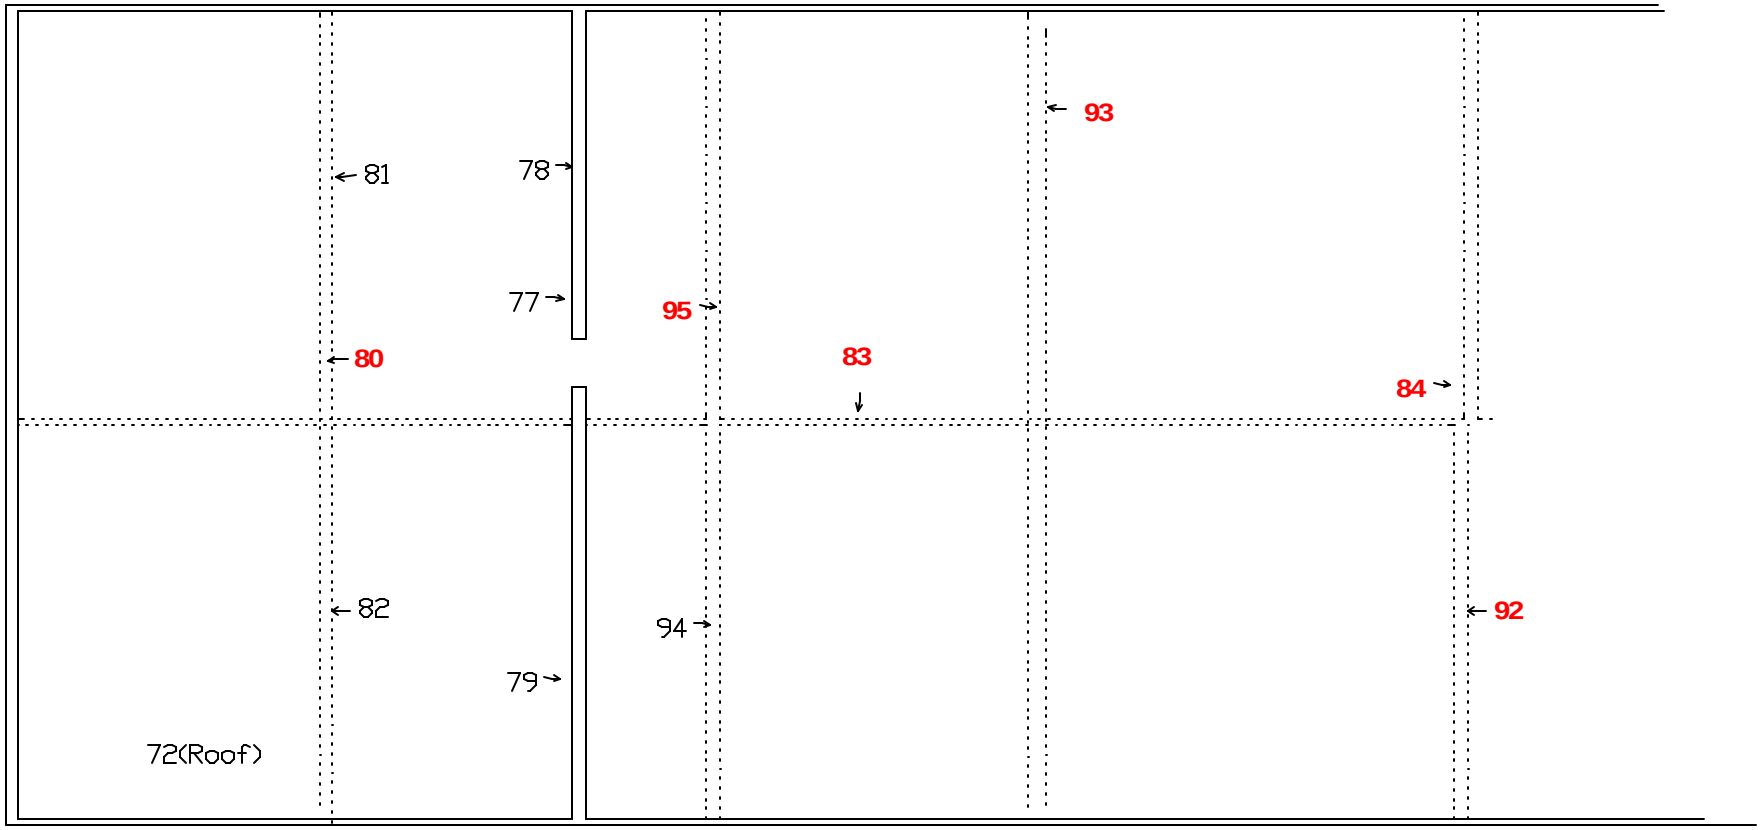
#= Positive Lead Sample Locations

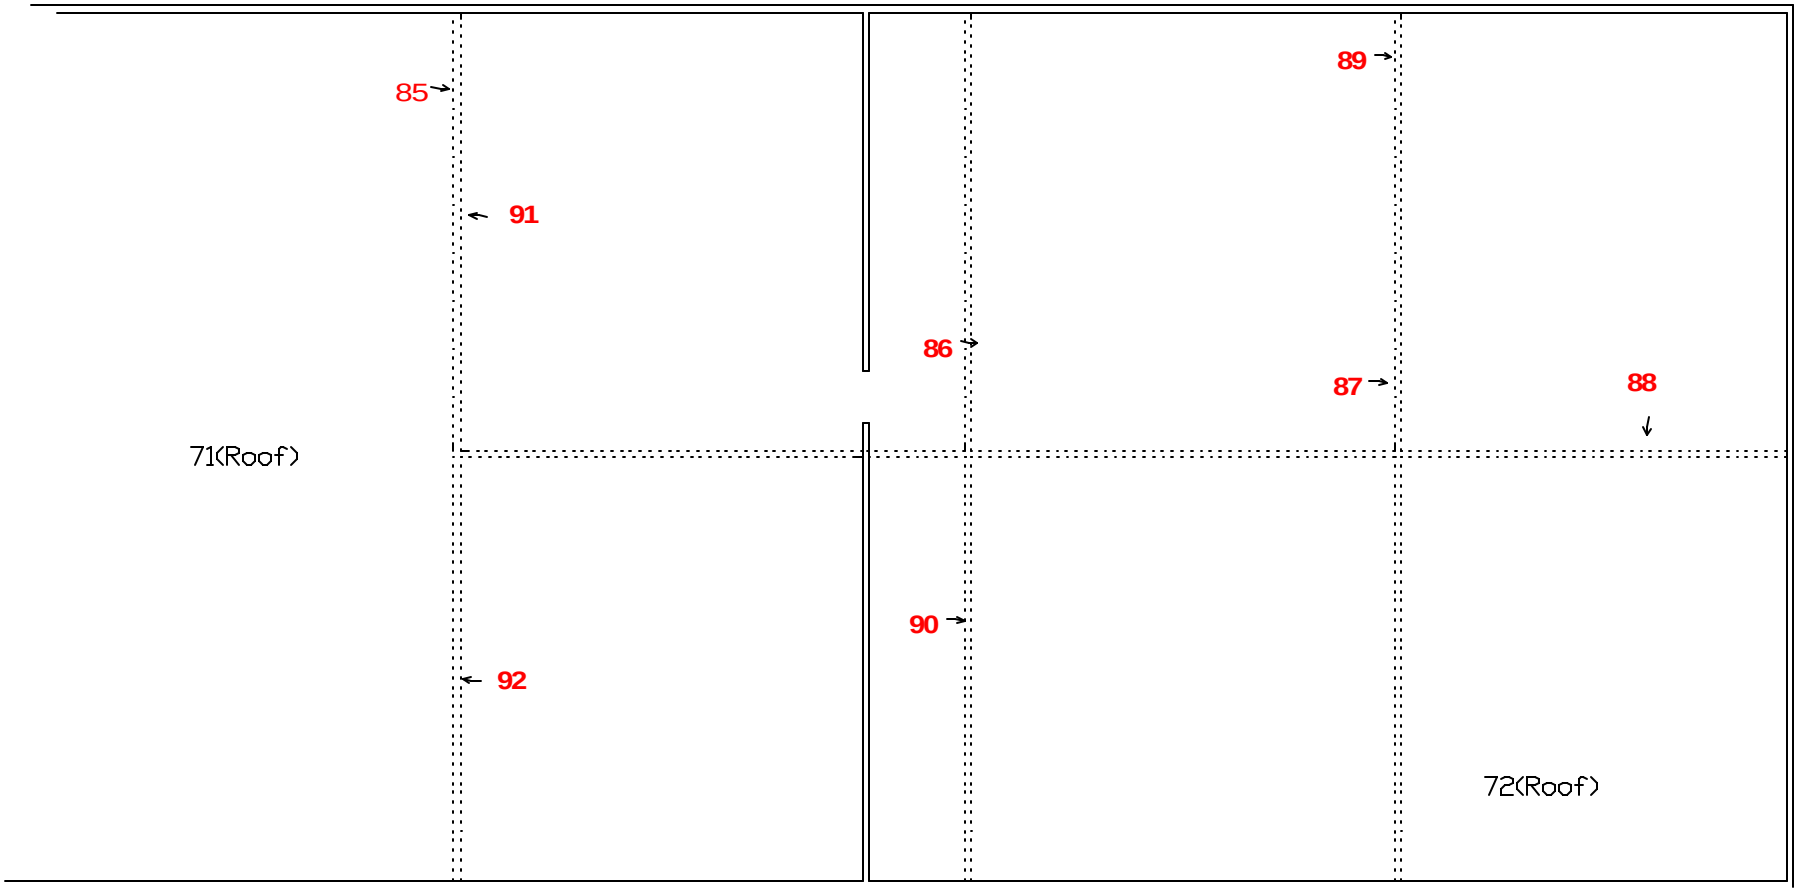
= Positive Lead Locations
